University Transportation Research Center - Region 2

# Experimental Study on Pre-stressed Concrete Box Beams From a Decommissioned Bridge Strengthened with Carbon Fiber Reinforced Polymer Anchors and Laminates

November 2023

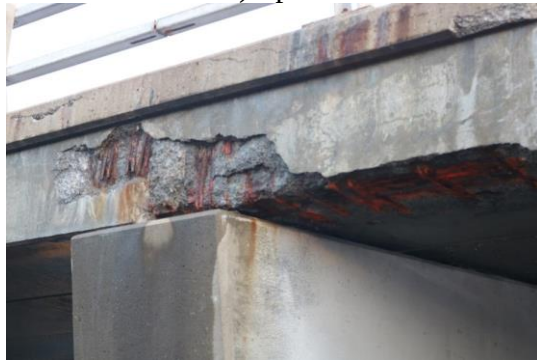
b) damage at the pier support

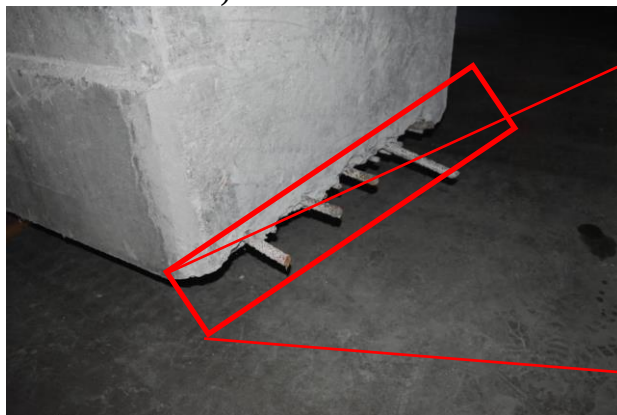
the west end, shown in Figure 2-6d, no other sign of damage or deterioration was observed. It should be noted that the cardinal coordinates, based on the beam orientation during testing at the SEES laboratory, are used in this report to refer to the various locations along their length. For instance, the “west end” refers to the end of the beam that is closer to the west side of the laboratory which remains the same for the entire testing period.

d) Steel reinforcement and concrete condition at the west end of the beam

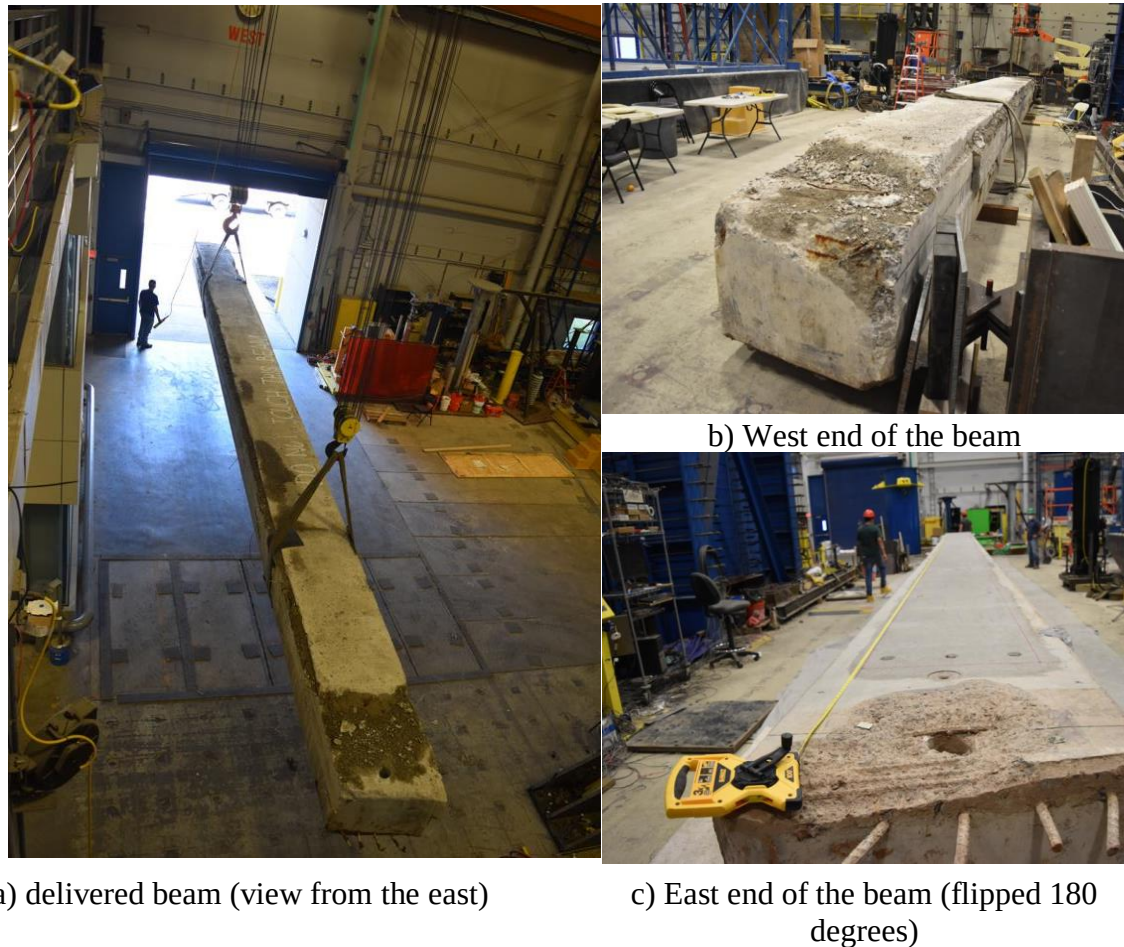
**Figure 2-7 Overall condition of Beam 2 after delivery to the SEES laboratory**

SEESL. Corrosion of transverse steel and concrete spalling were observed on both ends as shown in Figure 2-7b, and c. No visible shear or flexural crack was observed.

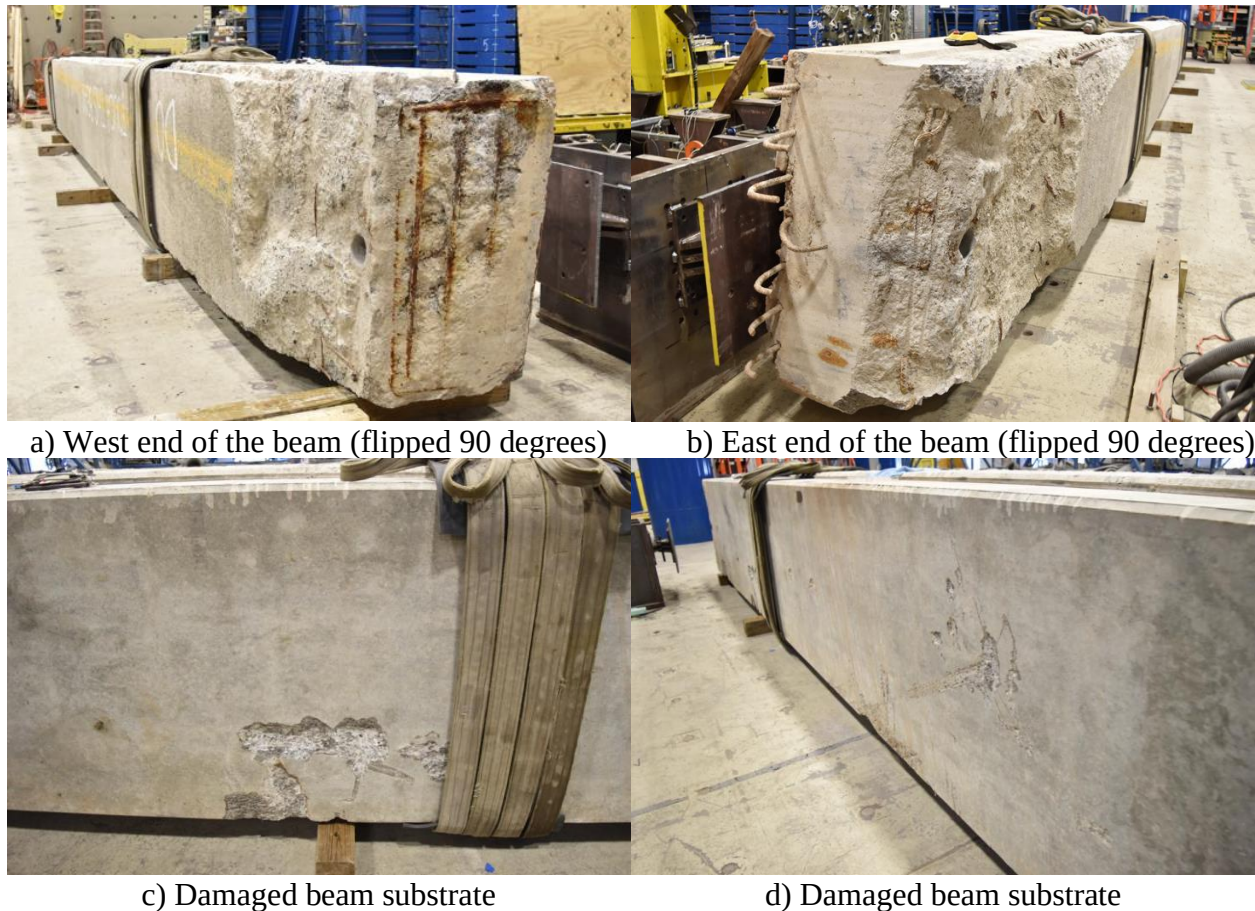
**Figure 2-8 Overall condition of Beam 3 upon delivery to the SEES laboratory**

The overall condition of Beam 3 is shown in Figure 2-8. Similar to the other two beams, the deck slab was removed at both ends of Beam 3. However, more severe damage was observed in Beam 3 at its ends, when compared to Beams 1 and 2, in terms of concrete spalling and corrosion of the transverse steel as shown in Figure 2-8a and b. Also, concrete spalling at the beam substrate occurred at several locations along the length of the beam due to the forceful beam removal using the excavators. Examples of the demolition-induced damage are presented in Figure 2-8c and d. This damage did not affect the load carrying capacity of the beam; however, it would reduce the bonding area and the effectiveness of the FRP retrofit. Hence, as discussed in Chapter

3, the beam was patched prior to the application of the FRP layer. As with Beams 1 and 2, no visible shear or flexural cracks were observed prior to the FRP application.

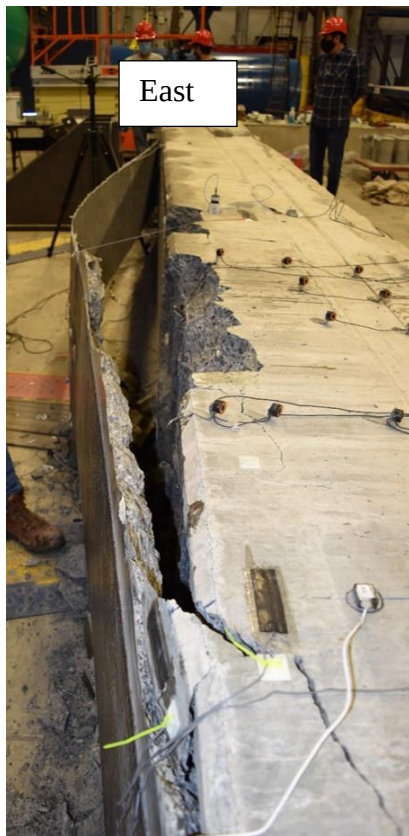
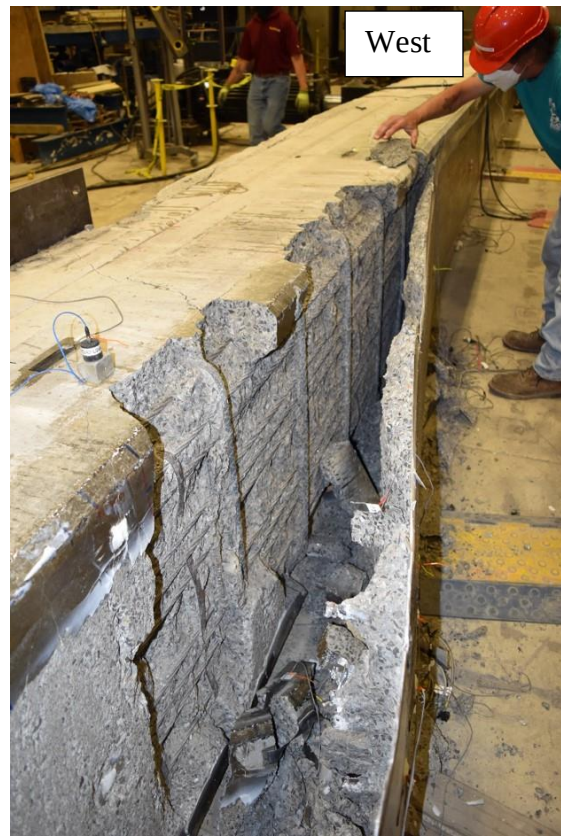
**Figure 5-15 Concrete spalling and FRP delamination at the west actuator location**

the beam, rupturing one anchor and leaving the other two in place as shown in Figure 5-17. The retrofit on the east side of the beam did not exhibit noticeable damage. It should be noted again that this difference in the state of damage between the east and west sides was most likely the result of the difference in the applied forces between the actuators that resulted in unsymmetric loading. Since the FRP system could not provide any resistance beyond its failure, the loading of the beam was continued, as this would allow to obtain the behavior of the unretrofitted beam. The loading stopped once the beam failed due to concrete crushing on the compression side.

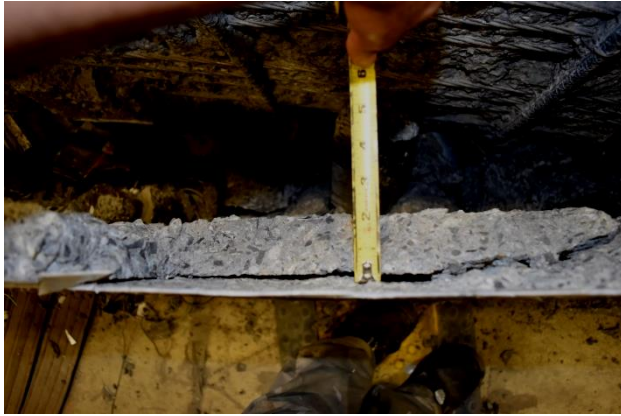
a) spalled concrete cover

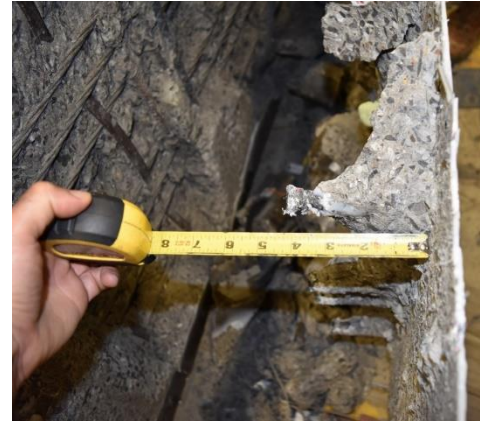
b) anchors pulled out

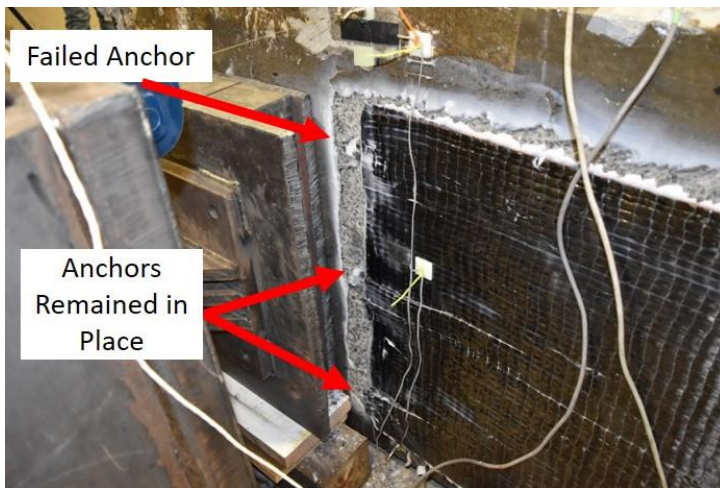
a) slid FRP laminate

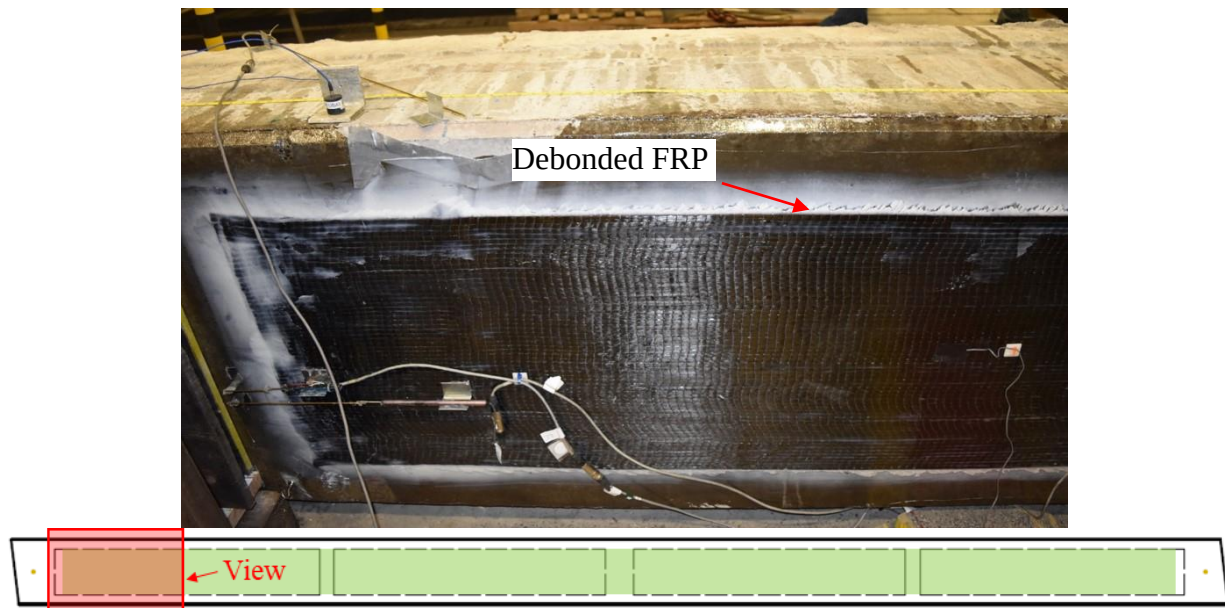
**Figure 5-30 FRP Debonding at the West end**

The test continued after the failure of the retrofit scheme. As shown in Figures 5-24 through 5-26, the resistance of the beam was stable as the actuator displacement increased. The test eventually stopped due to extensive concrete crushing at the location of the load application by the two actuators, after the midspan of the beam had been displaced by more than 26 in.

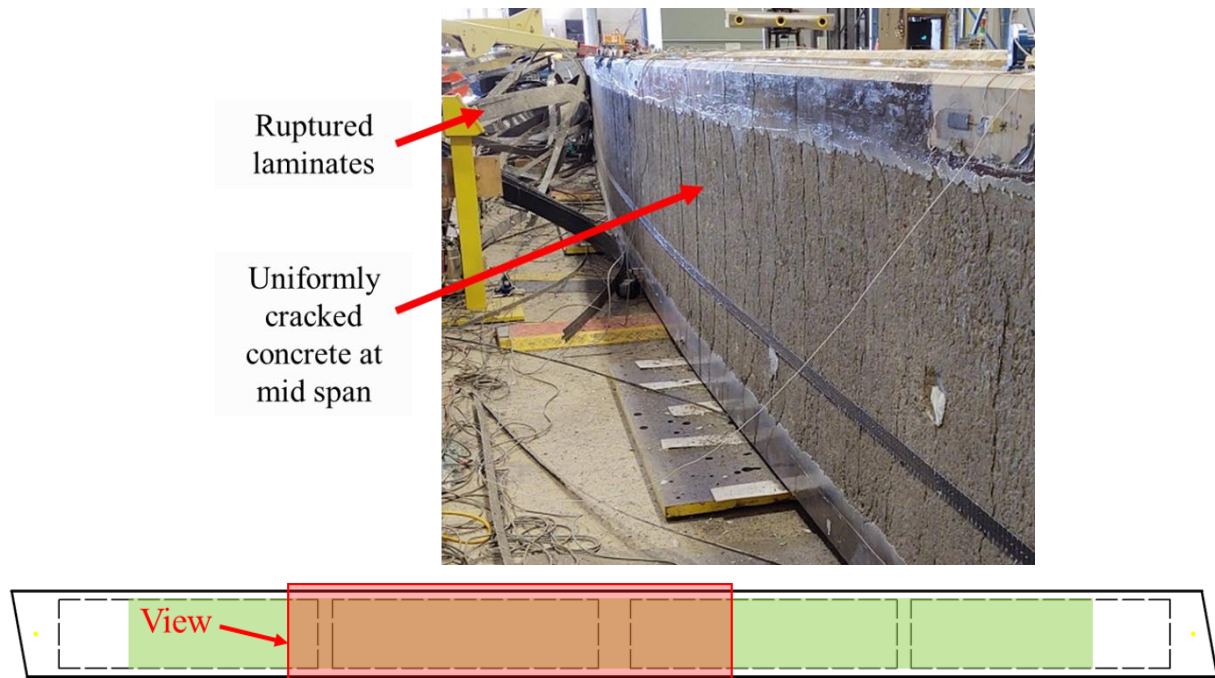
**Figure 5-46 State of damage at the middle of Beam 3**

Figures 5-46 through 5-48 present the state of the beam following the capacity-level tests. Except for a small segment, the FRP laminate was fractured between its supports, as shown in Figure 5-46. The end zones, which included seven FRP anchors sandwiched between FRP laminates, remained in place and only partial FRP delamination was identified. The delaminated segments, shown in Figure 5-48, are to the right and left of the white lines marked on the West and East end zones, respectively. Also, the location of the anchors was marked with red and yellow stickers on the West and East end zones, respectively, showing that the anchored zone remained almost intact.
