**Pedestrian Crosswalk Safety:
Evaluating In-Pavement, Flashing Warning Lights**

FINAL REPORT
March 2002

Submitted by
Peter Boyce, Ph.D. and John Van Derlofske, Ph.D.
Lighting Research Center
Rensselaer Polytechnic Institute

New Jersey
Department of Transportation
Division of Research and Technology
and
U.S. Department of Transportation
Federal Highway Administration

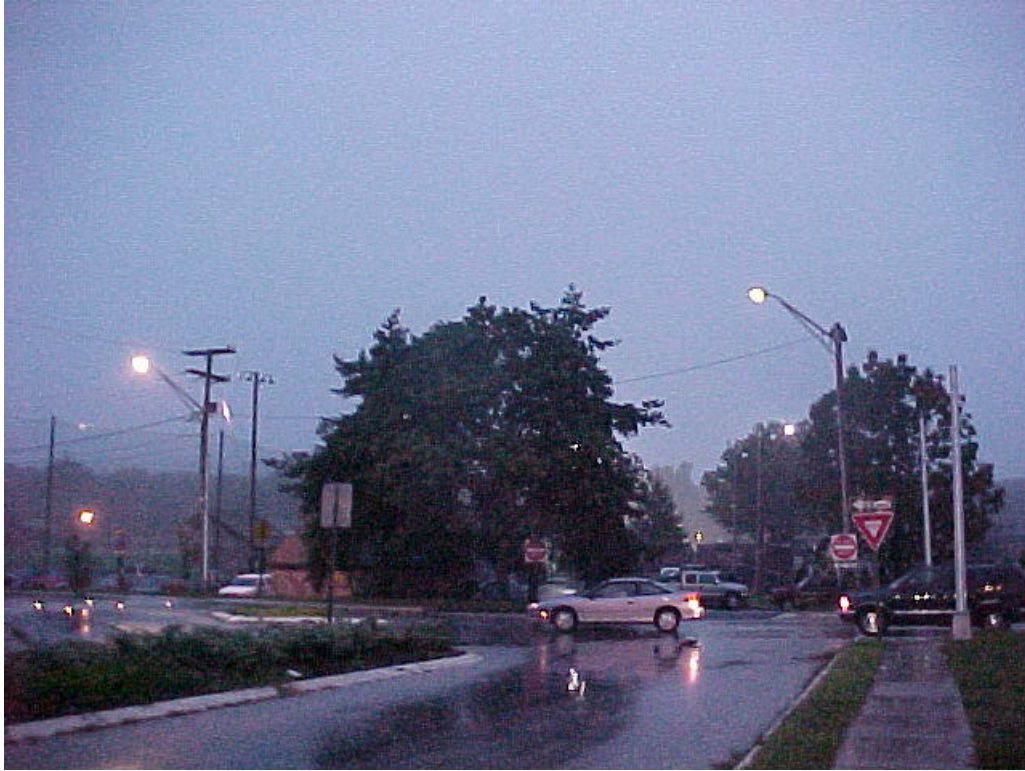
Figure 3. The cobrahead luminaires used to light the evaluation site at night.

Throughout the series of evaluations the lighting of the junction of Franklin Road and Savage Road has been provided by two drop-lens cobrahead luminaires, each one containing a 250 W high-pressure sodium discharge lamp (Figure 3). Each luminaire is mounted on an extension arm fixed to a wooden utility pole. The two poles are located close to the two crosswalks.

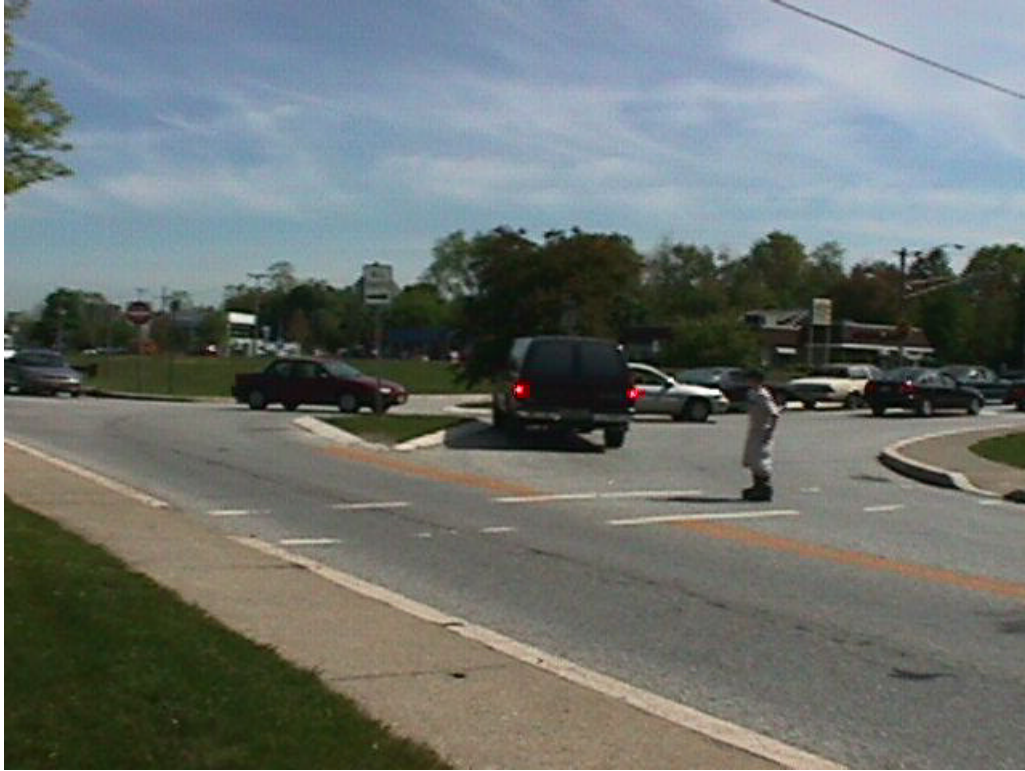
Figure 4. Crosswalk 2 at the time of the first evaluation.

The first evaluation was made on Saturday, 12th June 1999. At this time, there was only one marked crosswalk at the site, that being crosswalk 2 on the northwest side of the junction of Franklin Road and Savage Road. This crosswalk was linked to a sidewalk on the northwest side of Franklin Road. There was no sidewalk on the southeast side of Franklin Road so there was no marked crosswalk 1 at this point. Figure 4 shows the marking of crosswalk 2 from the sidewalk on Savage Road on the day of the evaluation. It is clear that the original marking of crosswalk 2 consisted of two parallel lines across the road, although by the time of the evaluation, the lines had been badly eroded by traffic.

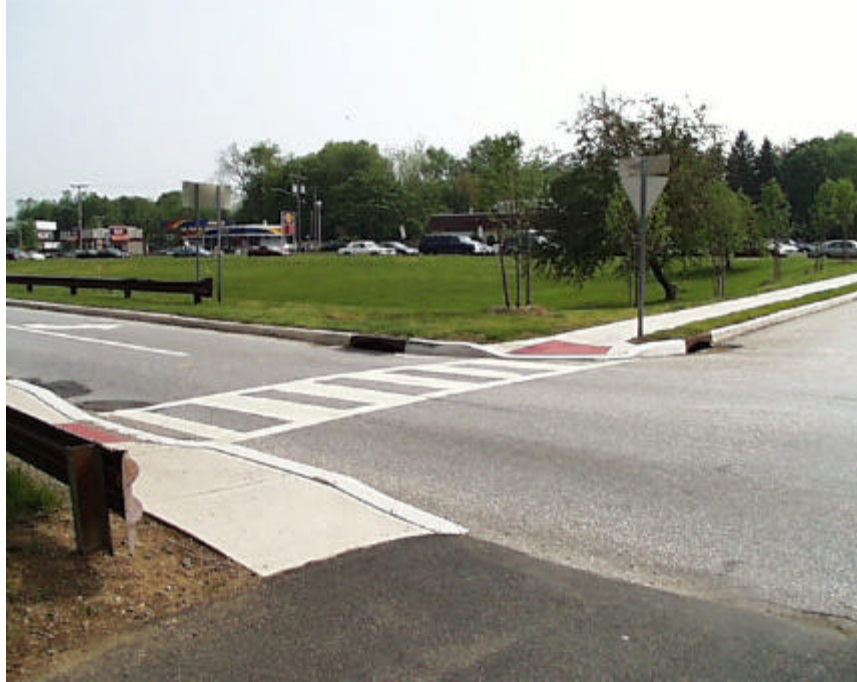
Figure 5. Crosswalk 1 at the time of the second evaluation.

The second evaluation took place on Saturday, 13th May 2000. By this time, a sidewalk had been constructed on the southeastern side of Franklin Road and a new crosswalk across Savage Road (crosswalk 1), complete with ADA ramps, had been finished. Both crosswalks had been newly striped in a grating pattern. Specifically, the striping consisted of alternate 2-ft-wide bars of white paint and 2-ft-wide pieces of asphalt, arranged to form a grating pattern, the upper and lower boundaries of the grating being closed by a continuous white paint line of 9" thickness. The overall width of both crosswalks was 7 ft. Figure 5 shows a view of crosswalk 1 at this stage and Figure 6 does the same for crosswalk 2.

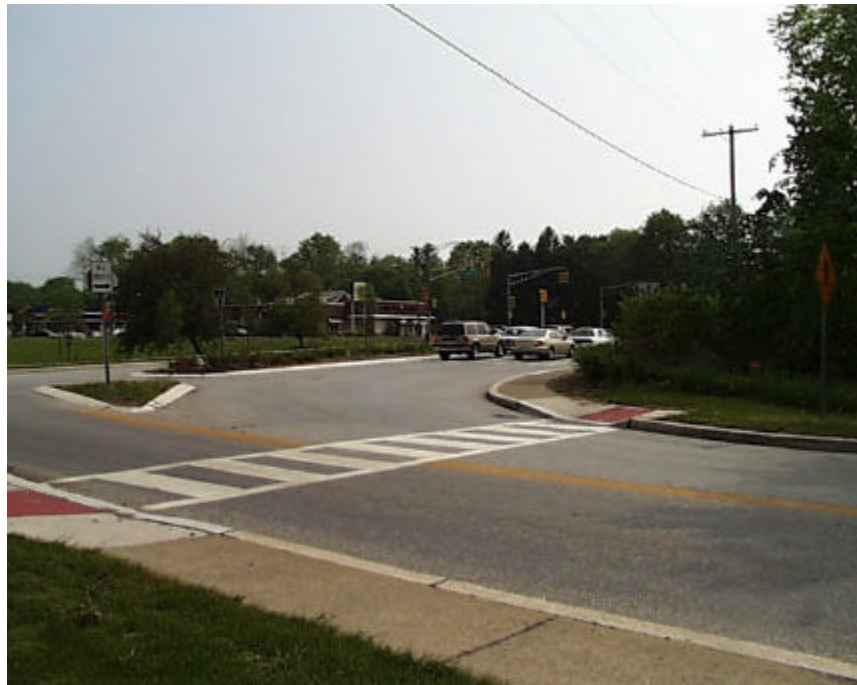
Figure 6. Crosswalk 2 at the time of the second evaluation.

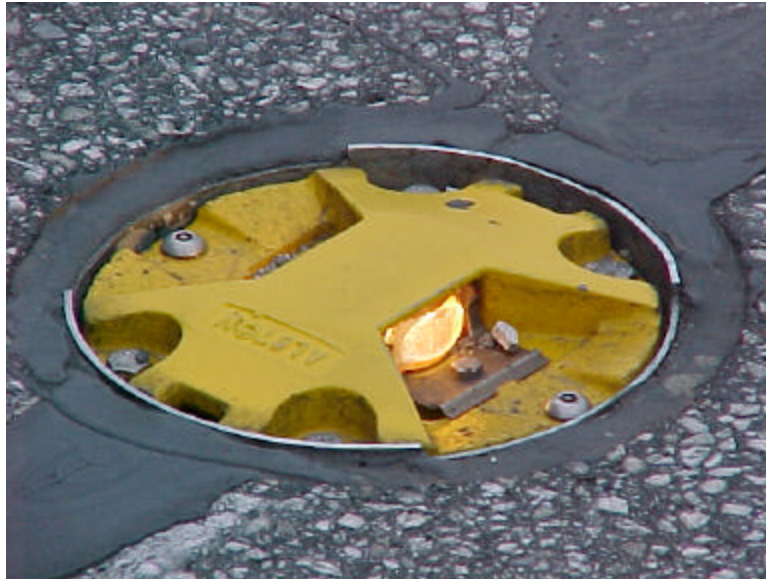
Figure 7. One of the in-pavement flashing warning lights, installed.

pavement flashing warning lights (Model ZA230) were purchased from Traffic Safety Corporation of Sacramento, California and installed by the New Jersey Department of Transportation. Figure 7 shows a close-up of one of the in-pavement flashing warning light units as installed.

The unit was originally designed for use on airport runways. Consequently, it is of rugged construction and designed to be set low enough in the pavement (projecting less than 0.50 inches above grade) that it will not be damaged by snowploughs. The light source used in the unit is a 45 W tungsten halogen lamp. The light output of the unit is predominantly in two directions, through apertures set at 180° to each other. The unit is installed so that these directions are along the main axis of the road. In Denville, only the direction towards approaching traffic emits light (the other direction is sealed). The light distribution from the unit is determined by the clear lens in the aperture of the unit. The effect of the lens is to direct a high luminous intensity beam along the road in the direction of approaching drivers. The color of the flashing warning lights was white. Four ZA 230 units were installed on crosswalk 1 and six units on crosswalk 2, as shown in Figure 8. Figures 9 and 10 show the installations at crosswalks 1 and 2 respectively.

A close examination of the units after one year in the pavement showed a large reduction in light output from new. There were two reasons for this reduction. The first was the presence of small debris in the incline leading to the lens of each unit. The second, and more important, cause was the deposit of a black film, probably rubber, over a large part of the lens through which light is emitted in each unit. Both these causes of decline in light output were easily removed using a brush and glass cleaner respectively.

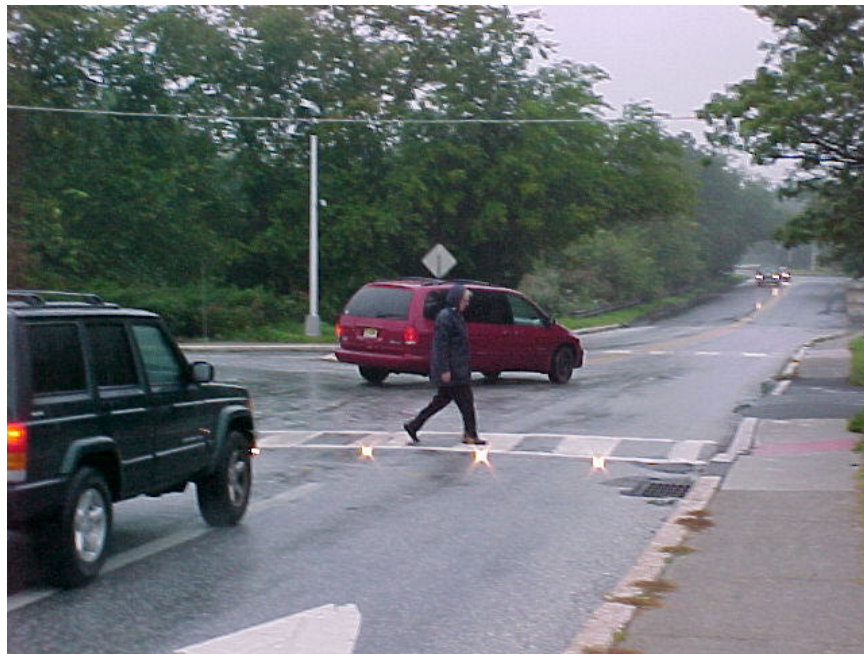
Figure 9. Crosswalk 1 with the in-pavement flashing warning lights installed and operating, at the time of the third evaluation.

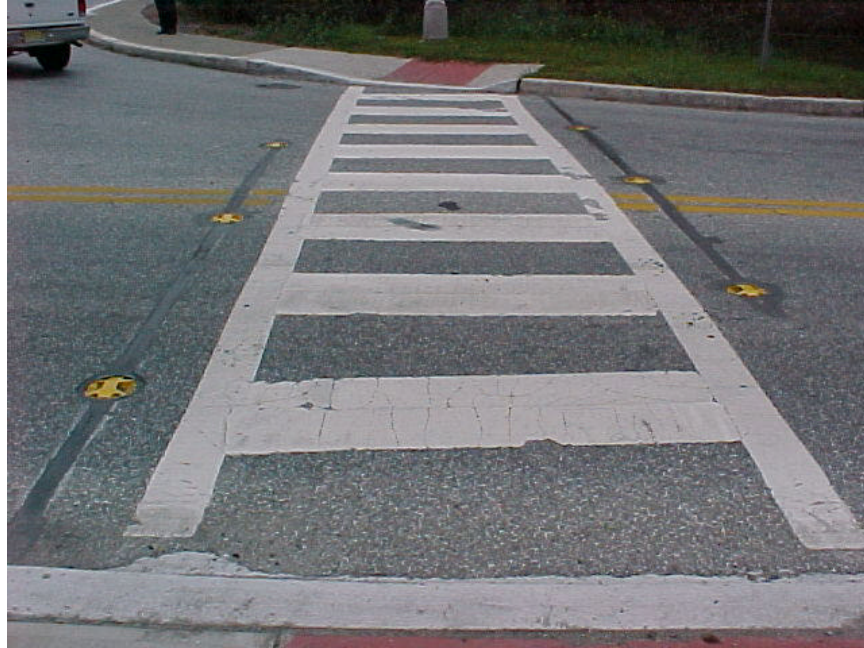
Figure 10. Crosswalk 2 with the in-pavement flashing warning lights installed, at the time of the third evaluation.

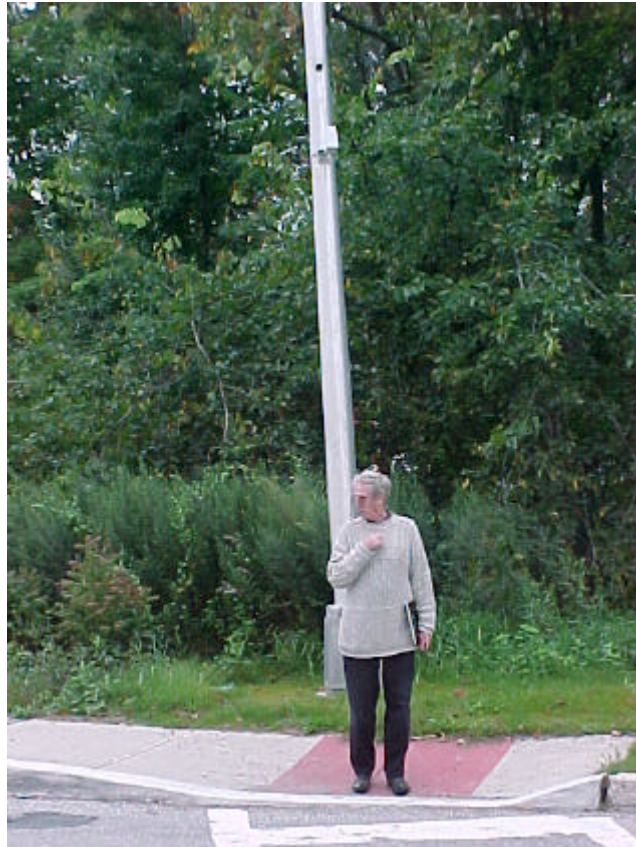
Figure 11. One of the four microwave detectors used to activate the in-pavement flashing warning lights. The detector is in the small box on the pole behind and above the pedestrian.

The activation of the in-pavement flashing warning light units was by four microwave detectors (Model AD1400) also purchased from Traffic Safety Corporation. One of these detectors was mounted on a pole at either end of both crosswalks. Figure 11 shows the location of one of the AD1400 detectors relative to the pedestrian. These devices detect the presence of a pedestrian in the detection area. The pedestrian has to be in the detection area for a minimum time before the flashing warning lights are activated. This time delay from detection to activation is necessary so that pedestrians passing through the detection area but continuing along the sidewalk do not trigger the flashing warning lights. The sensitivity of the detector, the detection area and the delay time are all adjustable on site.

The pole-mounted activating system has adjustments of coverage area, sensitivity and time delay. These adjustments are used to ensure that the in-pavement flashing warning lights are only operated when a pedestrian is waiting to cross and are not activated by a pedestrian walking along the sidewalk past the crosswalk, nor by passing traffic. At the time of Evaluation 3, i.e., one week after commissioning, it was observed that the in-pavement units were sometimes activated when there was no pedestrian present. Examination of the activation of the in-pavement flashing warning lights for several hours during Evaluation 5 revealed the pattern of activation shown in Table 9.

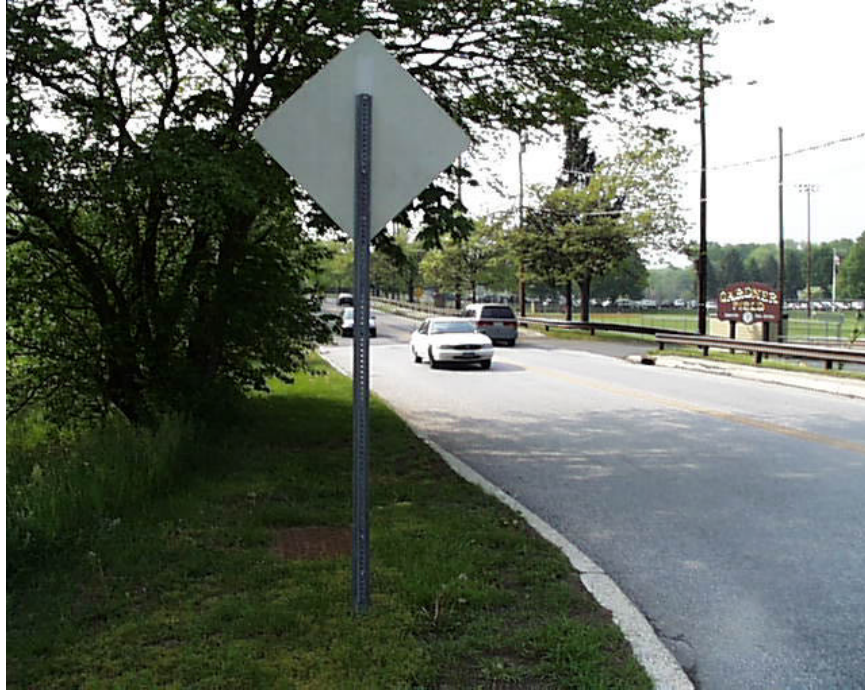
Figure 12. View up Savage Road to the northwest, from the Franklin Road side of Crosswalk 2, obscured by shrubs.

Finally, the interviewees were asked if they had any comments about the crosswalks. The comments made are listed in Table 8. There are a number of points made in these comments that are themselves worth commenting on. There are two points that are repeated in Evaluation 2. The first is the difficulty of seeing up Savage Road from one side of Crosswalk 2 because of the overhanging trees and shrubs on the adjacent land (Figure 12). The other is the difficulty produced by having to look out for vehicles coming from several different directions. This was emphasized by one pedestrian who, quite rationally, choose to always use Crosswalk 1 because then it was necessary to look out for traffic from only two lanes, both in the same direction. For Crosswalk 2, it is necessary to look out for vehicles in 4 lanes in four different directions (See Figure 2).

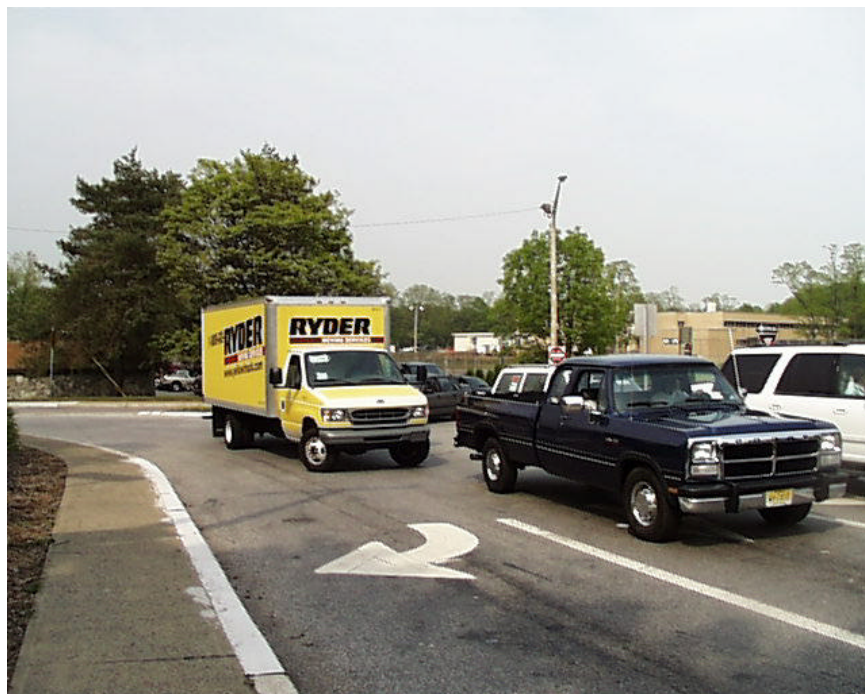
Figure 13. Blockage of some directions of travel in the area of the crosswalk by traffic backing up from the traffic signals at US Route 46 and Franklin Road.

While making the evaluations on site, the authors had an opportunity to observe drivers' behaviors. Two aspects of that behavior are of relevance here. The first is that traffic backing up from the traffic signals on US Route 46 sometimes produced partial blockages of different lanes between the two crosswalks. The most common blockages occurred for directions 2 and 3 because of vehicles coming from directions 2 and 4 (Figure 13). Occasionally, this situation was exacerbated by a vehicle coming out of Gardner Field and blocking direction 1. The importance of such blocking for the use of the crosswalks is that the vehicles obscure the drivers' view of the crosswalk and the pedestrians' view of the traffic. This means it is sometimes not possible for a driver traveling in direction 1 to see if a pedestrian is waiting to cross from one side of the two crosswalks, or even if a pedestrian has already started to cross, until the pedestrian emerges from behind a vehicle. Striping does not do anything to help in this situation but the in-pavement flashing warning lights would, if drivers were confident that their operation meant a pedestrian was using the crosswalk.
