# Final Report

## Bridge Vehicle Impact Assessment

Performing Organization: The City College of New York, CUNY

December 2011

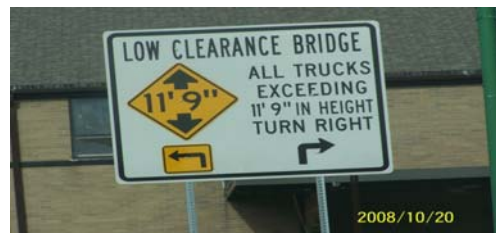
**Figure 3-1: Low Vertical Under-clearance Sign Installed near the Bridge on George Urban Blvd in the Village of Depew, New York.**

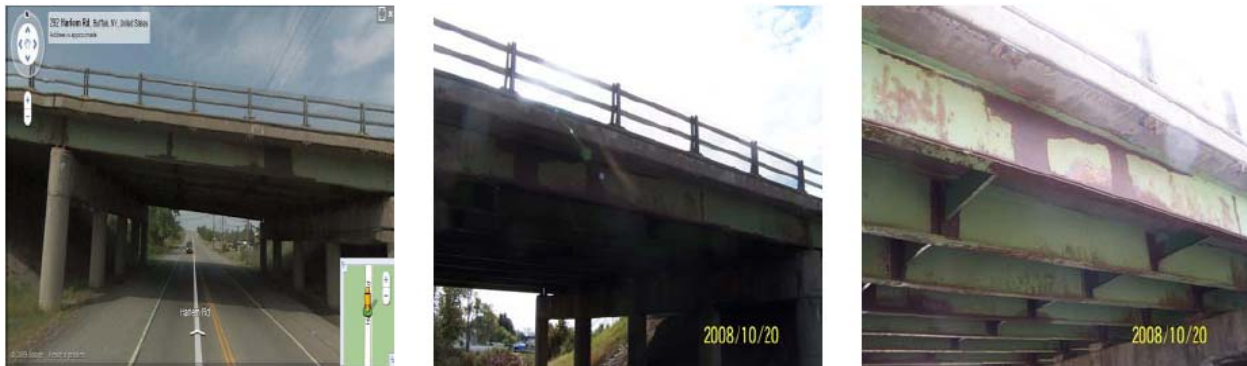
**Figure 3-2: Damages to the Girder of BIN 5060589 Because of Multiple Hits.**

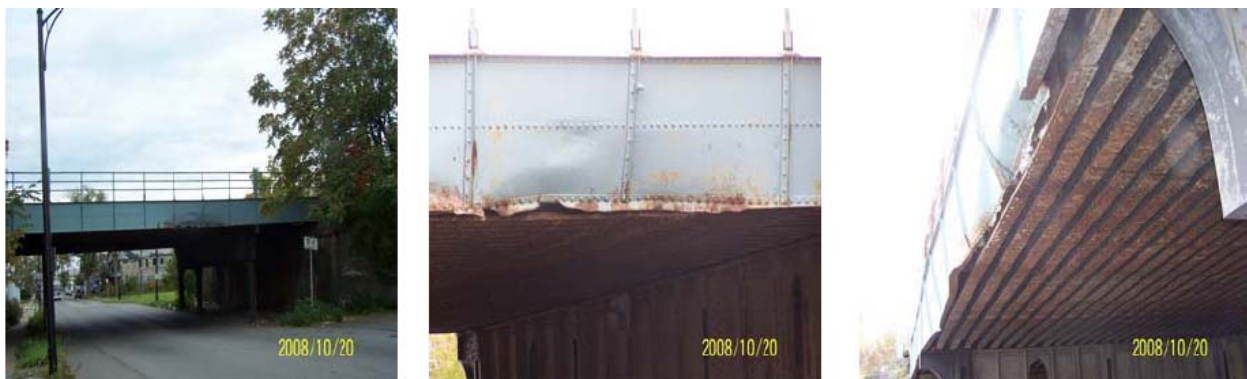
**Figure 3-3: Damages to the Girder of Bridge 7708160 Because of Multiple Hits.**

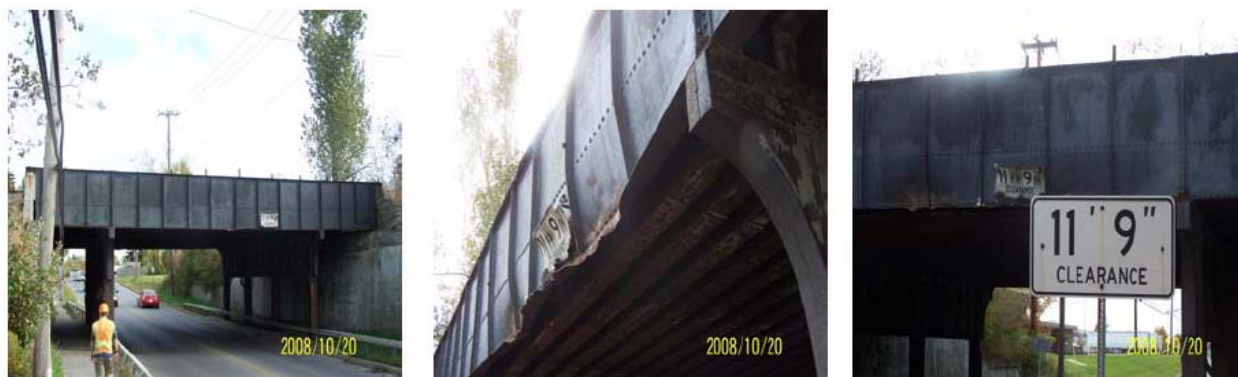
**Figure 3-4: Damages to the Front Face of the Bridge 7708610 Because of Multiple Hits.**

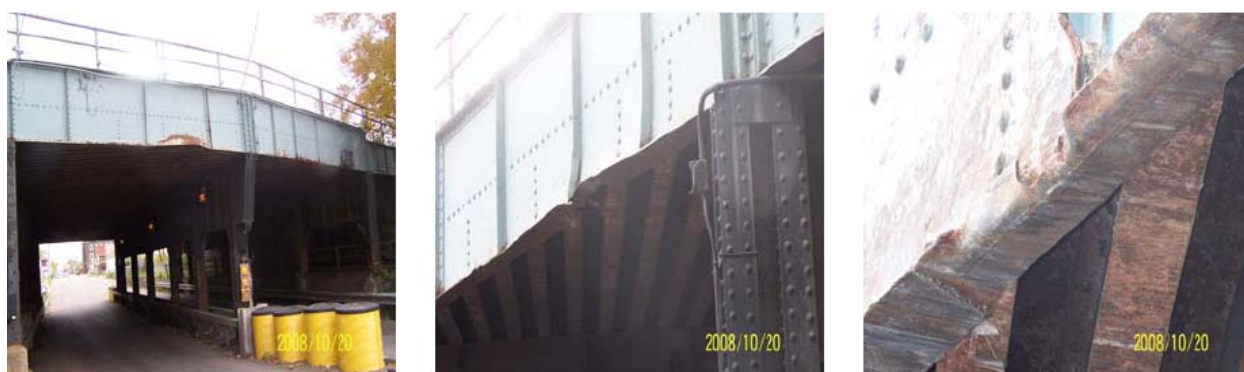
**Figure 3-5: Damages to the Front Face of the Bridge 7046420 Because of Multiple Hits (hit 41 times).**

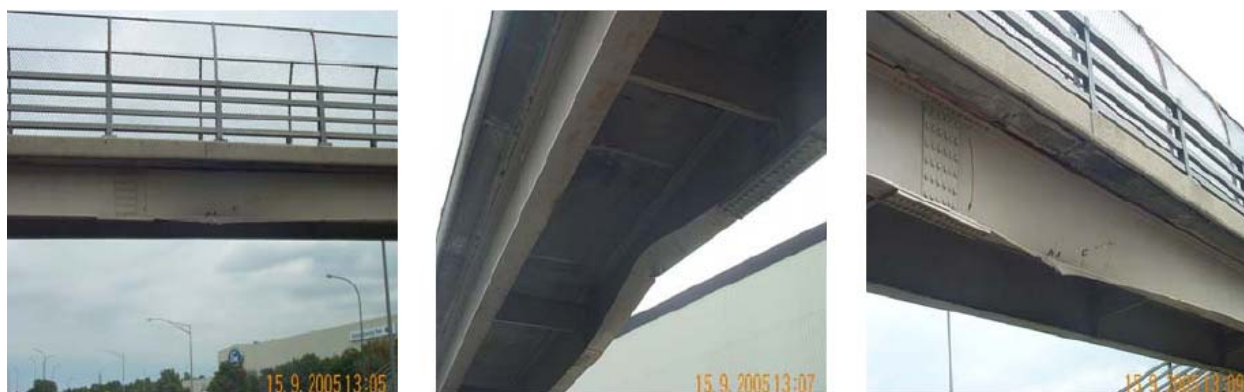
**Figure 3-6: Damages to the Bridge 1001410 Observed During an Inspection.**

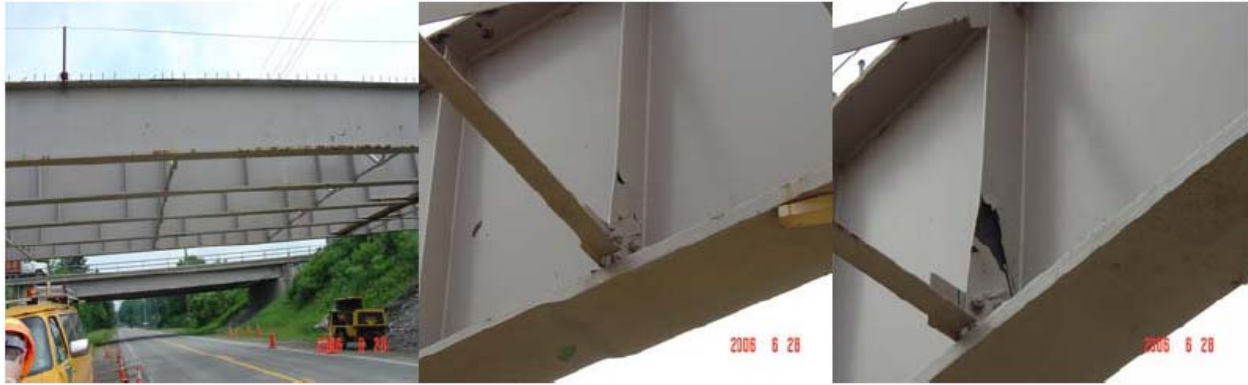
**Figure 3-7: Damages to the Bridge 1092032 Observed During an Inspection.**

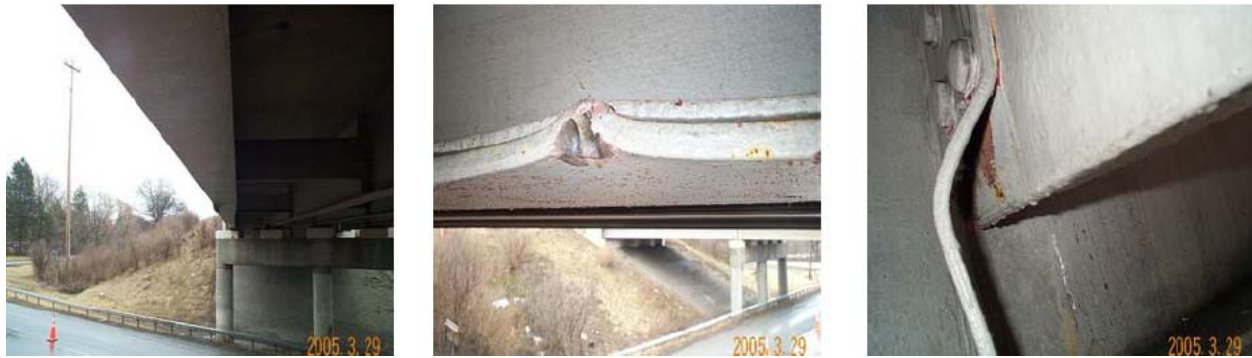
**Figure 3-8: Damages to the Bridge 1062872 on the Route 400 over Jamison Road Observed During an Inspection.**

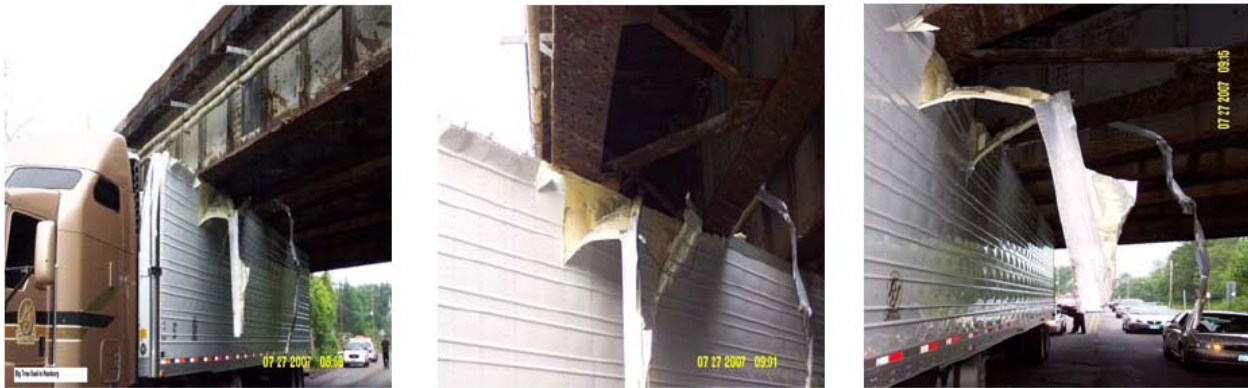
**Figure 3-9: Impact to the Bridge 7050631 on Big Tree Road in Hamburg, New York.**

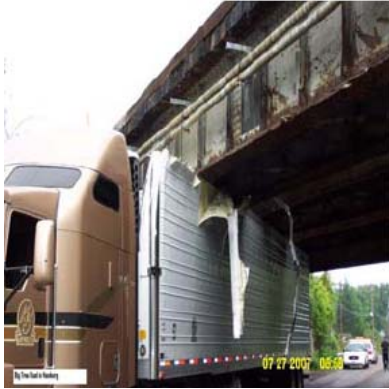
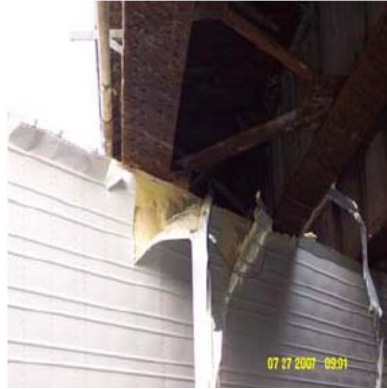
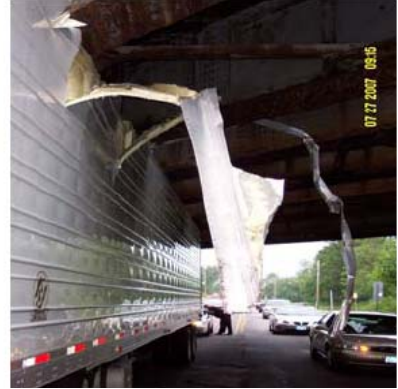
**Figure 3-10: Impact to the Bridge 1001410.**

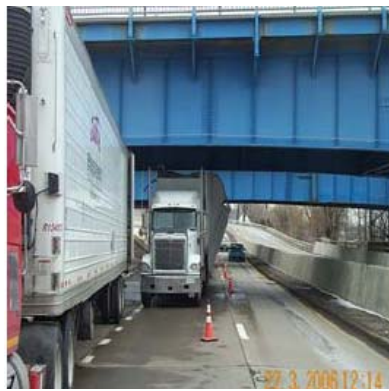
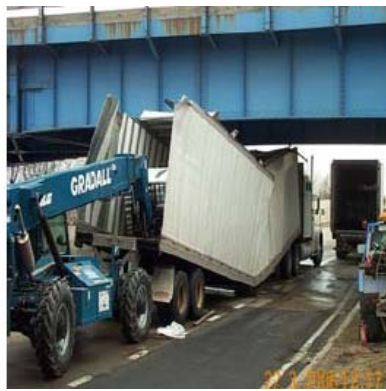
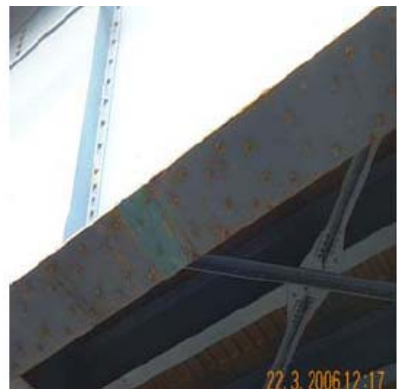
**Figure 3-11: Impact to the Bridge 5045751 on March 22, 2006.**

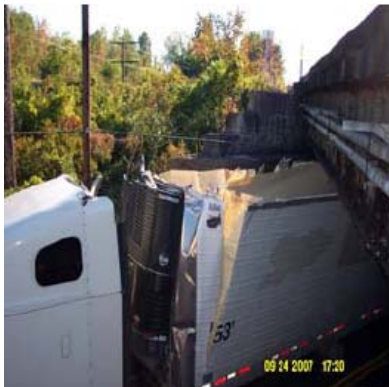
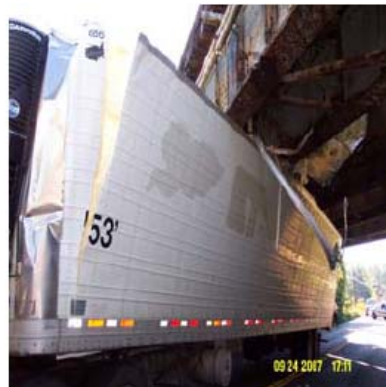
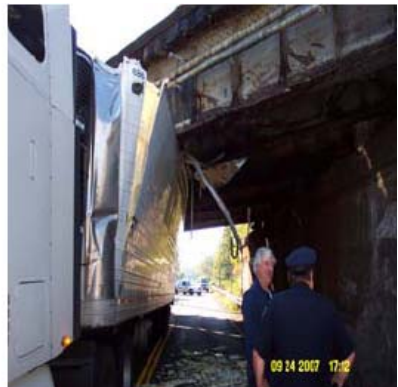
**Figure 3-12: Impact to the Bridge 7050634 on Sept. 24, 2007.**

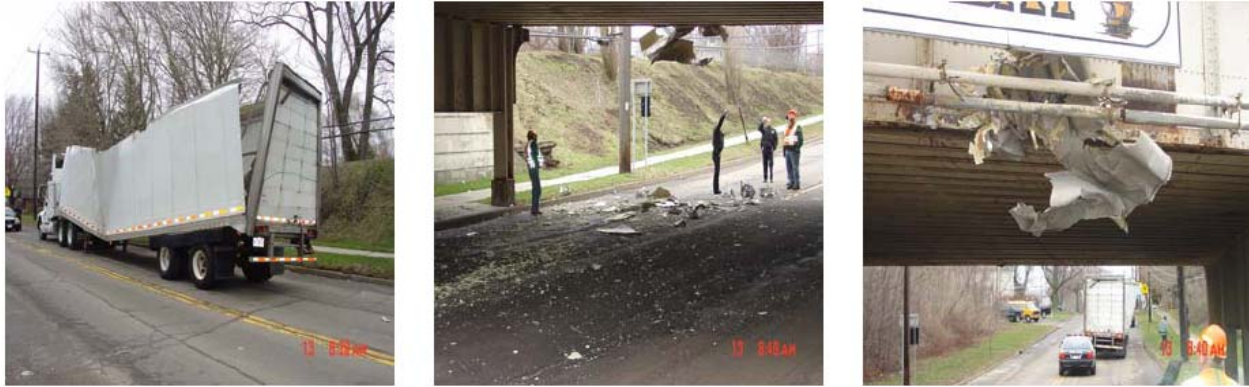
**Figure 3-13: Impact to the Bridge 7707520.**

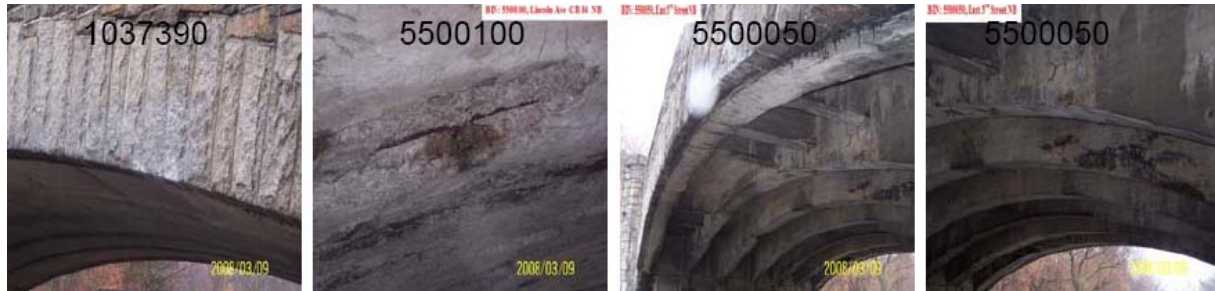
Figure 3-18: Typical Damages to the Bridges in Region 8 because of Multiple Hits.

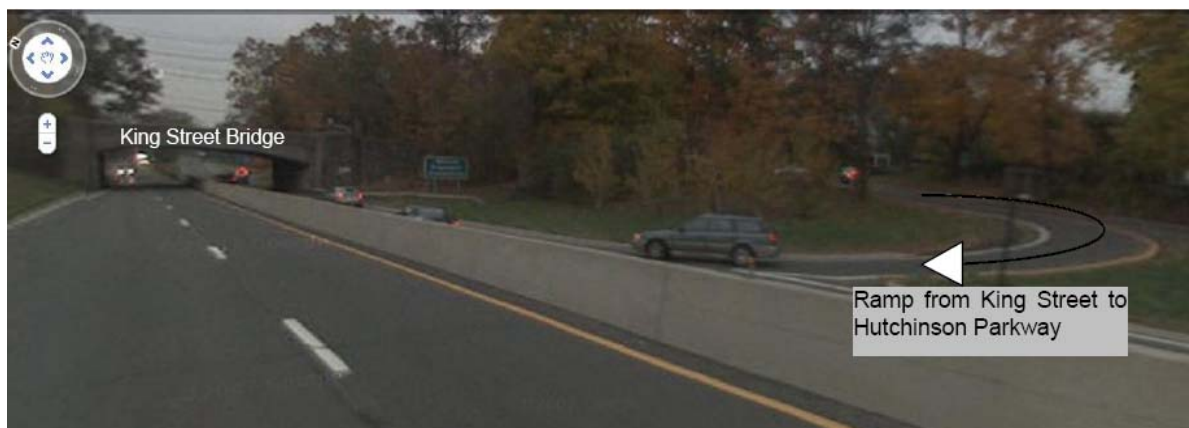
Figure 3-19: Ramp from King Street to Hutchinson Parkway (Photo from Google Maps)

1. Signs warning drivers about the low vertical under-clearance are not easily visible or obvious. For example, Figure 3-19 shows the ramp to the northbound lane of the Hutchinson Parkway from the King Street Bridge, which has been hit 62 times. The bridge is approximately 100 ft from the end of the ramp. As a truck driver who has entered the ramp by mistake exits from the ramp, he has very small amount of time to stop before hitting the bridge. The only sign warning drivers not to enter the ramp is “Passenger Cars Only”, as shown in Figure 3-20. This sign appears before the entrance to the ramp on King Street, is not easily visible to drivers entering the ramp, and may not be adequate to warn truck drivers about a possible collision with a low under-clearance bridge ahead. This applies to all bridges that have been hit multiple times in Region 8.

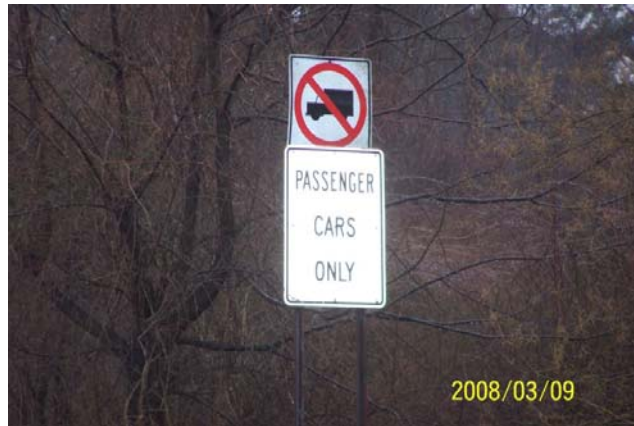
**Figure 3-20: Sign at the Entrance of Parkways in Region 8.**

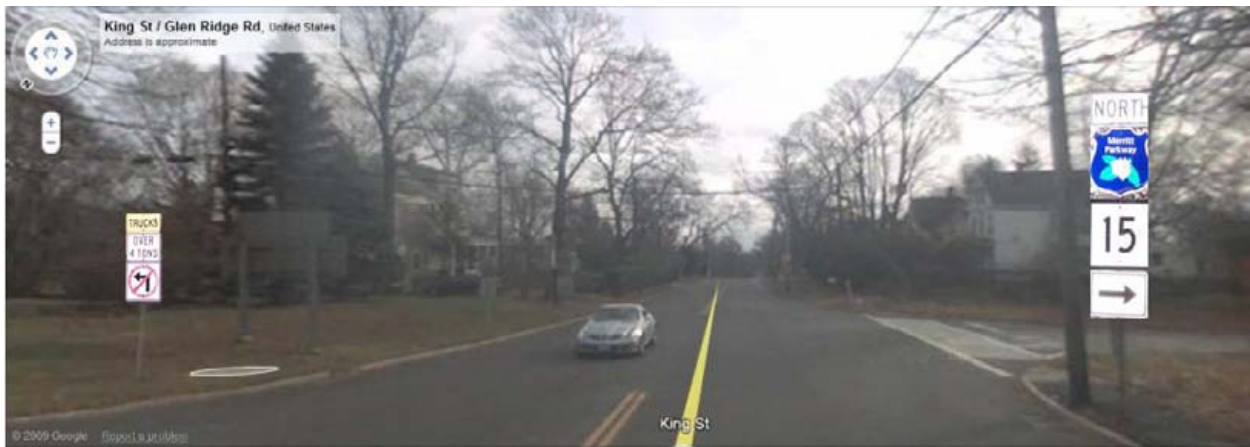
**Figure 3-21: Entrance to the Hutchinson Parkway from the King Street (Photo from Google Maps)**

2. A sign at King Street ramp to the Hutchinson Parkway may also be contributing to increased truck traffic on the Hutchinson Parkway, that itself may lead to increased impacts on the King Street Bridge. Figure 3-21 shows the entrance on the right to the NB Hutchinson Parkway from King Street. The sign on the entrance ramp doesn't warn drivers not to enter the Hutchinson Parkway. On the other hand, there is a sign on the left that prohibits trucks over 4 tons from making a left turn on a local street (Glen Ridge Rd). Since truck drivers are prohibited from turning left, they may be tempted to turn right on the ramp to the Hutchinson Parkway.

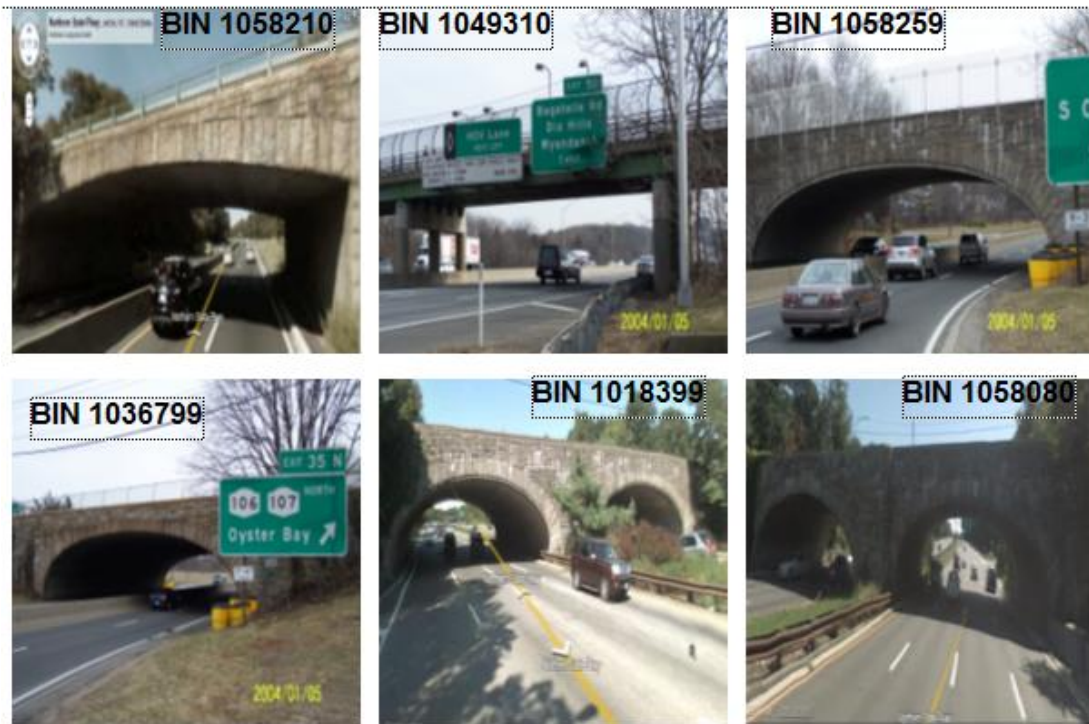
**Figure 3-23: Typical Bridges in Region 10 Hit Multiples Times by Trucks.**

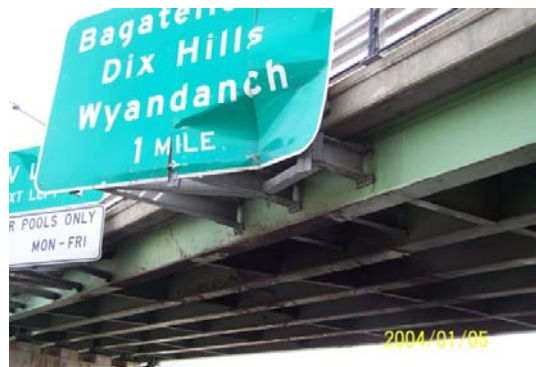
**Figure 3-24: Damage to the Sign on the Bridge 1049310 Over I-495.**

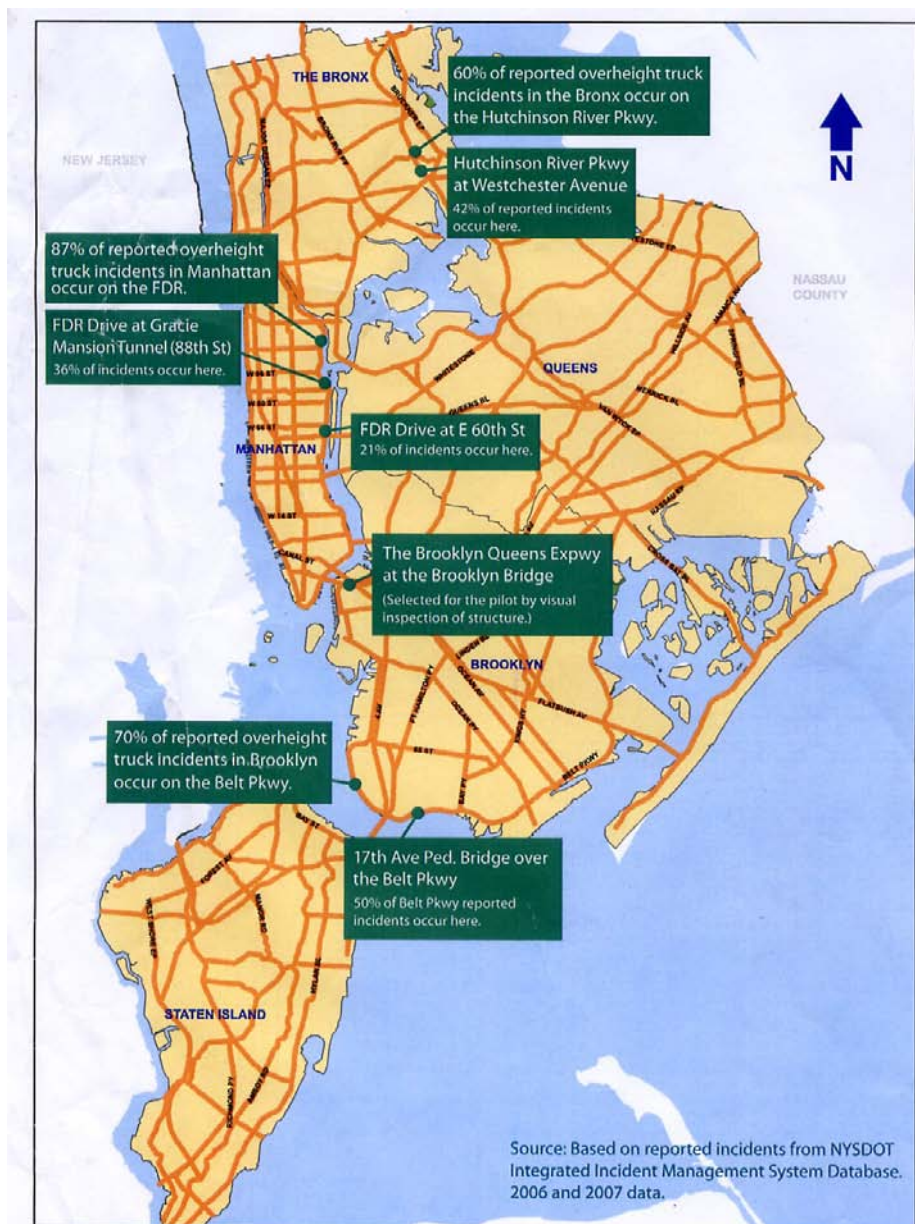
**Figure 3-26: Bridge Vertical Clearance Signage Pilot Study Locations in New York City Area.**

New York City Department of Transportation has been carrying out a “Bridge Vertical Clearance Signage Pilot Study” to reduce hits to bridges that have been hit multiple times. Figure 3-26 shows a map with locations of bridges being studied in this program. The PI visited several of these bridges with Mr. Andrew Hoang of the NYCDOT on April 20, 2009.

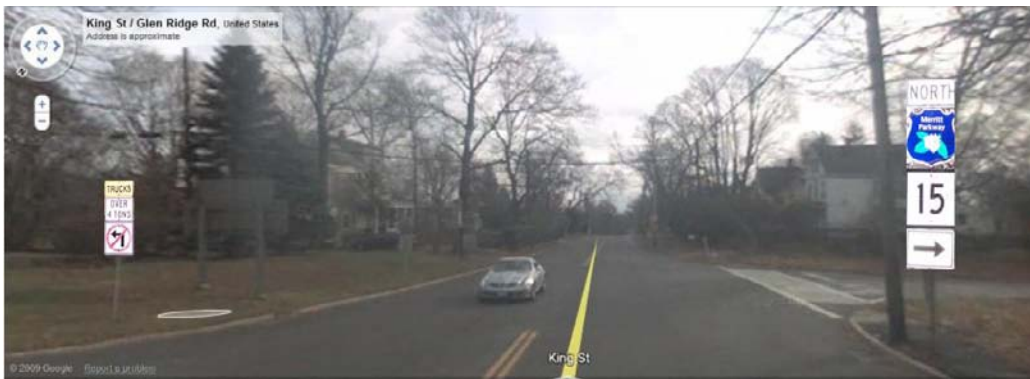
**Figure 4-1: Signs on King Street near the Entrance of Hutchinson (Merritt) Parkway (Photo from Google Maps).**

- (iv) The bridge carrying King St over Hutchinson Parkway has been impacted 62 times. Bridges on either side of this bridge over Hutchinson Parkway have been impacted less frequently. This may be occurring due to a misleading "No Left for Trucks" sign, which may imply that a right turn is allowed (See Figure 4-1 below). This confusion should be corrected by installing a "No Trucks or Tractors" sign at the ramp of the Parkway.

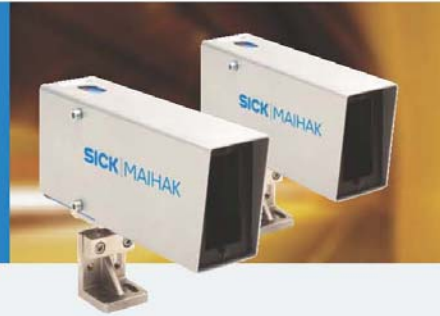
#### Detection of vehicles with overheight

The HISIC450 detects vehicles which are too high – at tunnel entrances, low underpasses or bridges, for example. Stop and alarm signals are immediately activated when a vehicle infringes the light beam.
