Final Report

Determining Binder Flushing Causes in New York State

Performing Organization: Rutgers University

December 2014

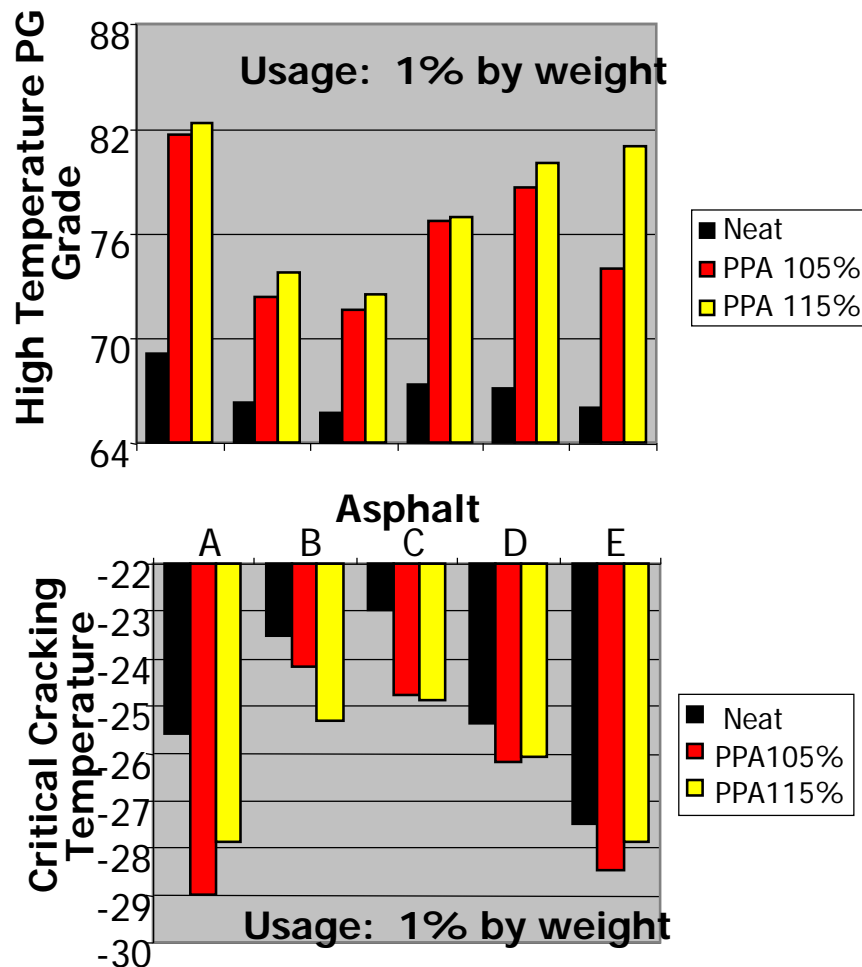
Figure 2 shows a perfect example of this phenomena, where 5 different crude sources were modified with the same percentage of PPA and had different effects. The data in Figure 2 was provided by Baumgardner (2009).

Figure 1 - Change in Asphalt Binder PG Properties Due to PPA Modification – 5 Different Crude Sources

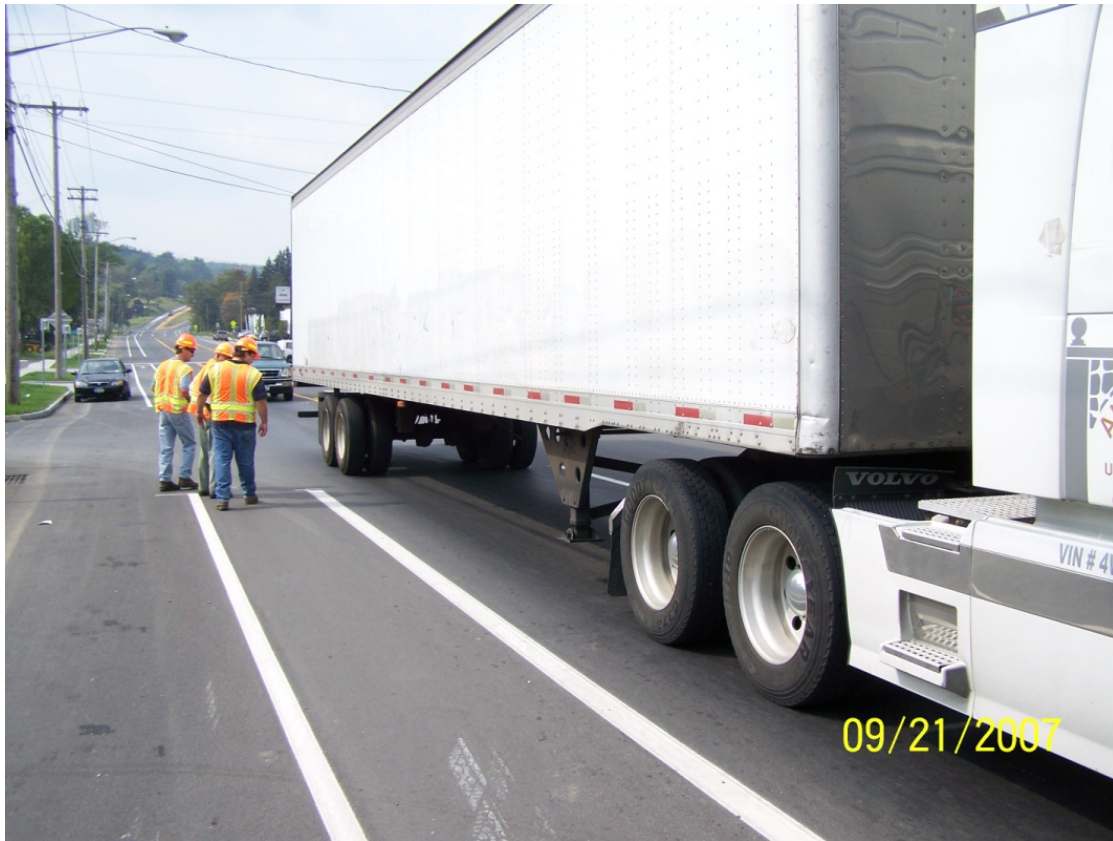
Figure 2 - Flushing at Intersection of Rt 20 (< 30 Million ESAL's)

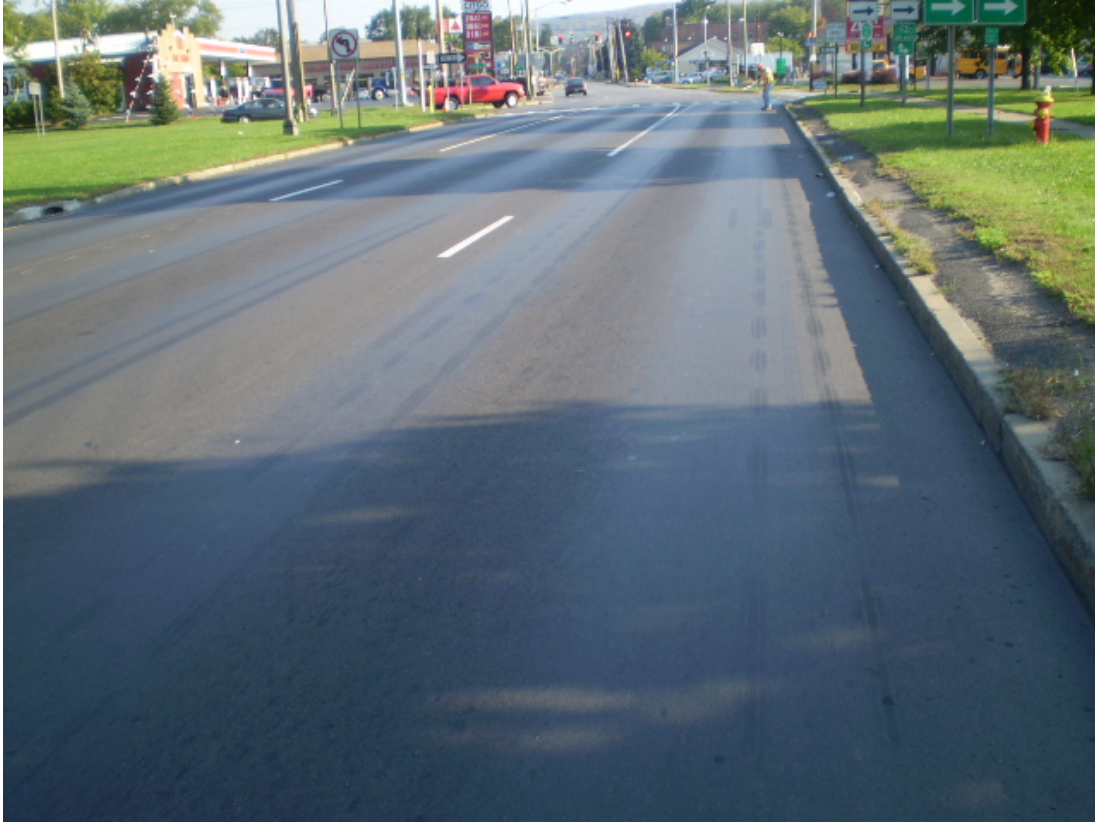
Figure 3 - Flushing at Intersection of Rt 921C (< 30 Million ESAL's)

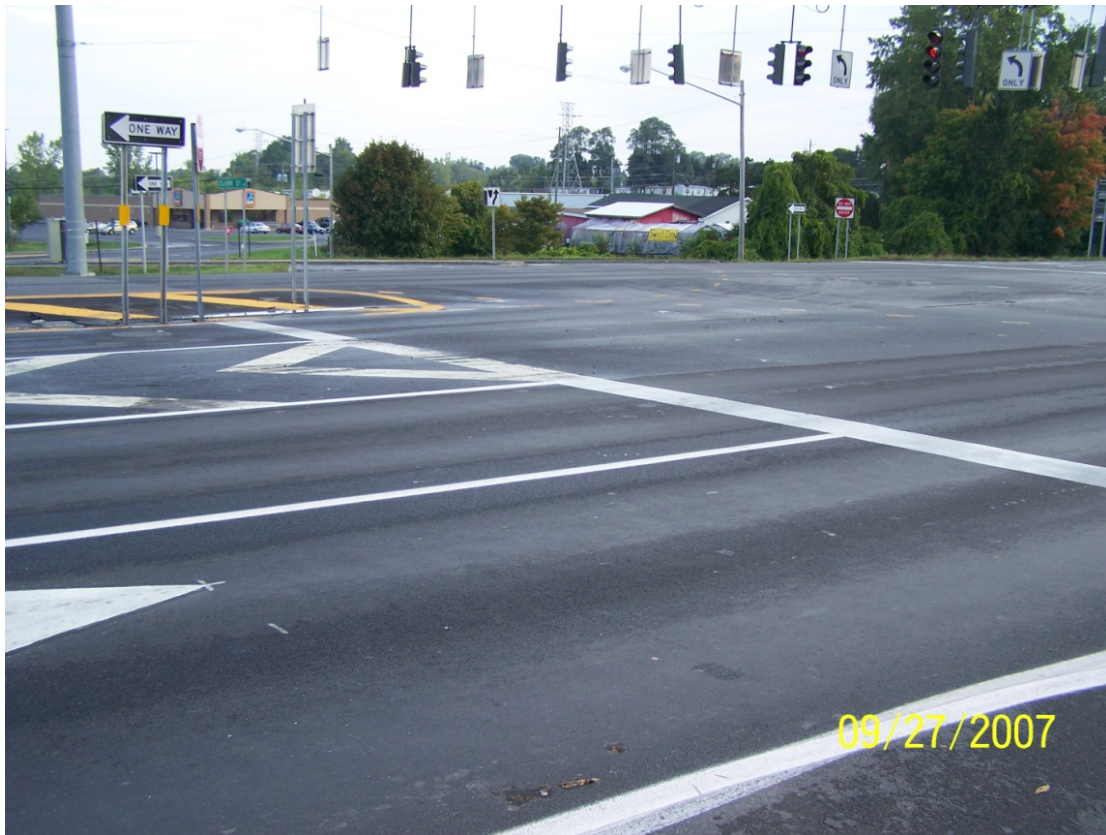
Figure 4 - Flushing at Intersection of Rt 5 (< 30 Million ESAL's)

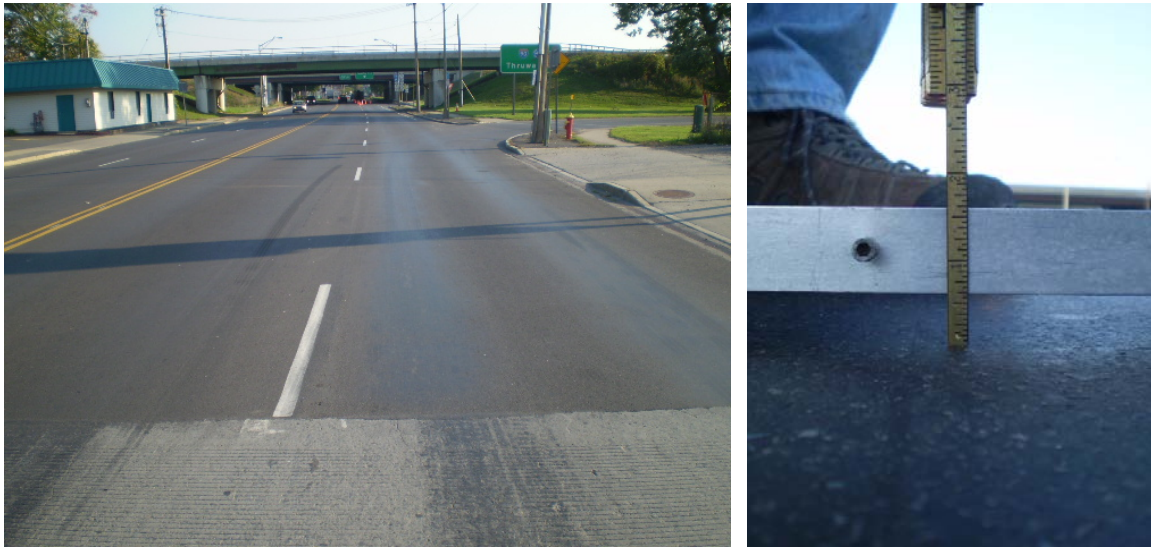
Rt 921C was reported to have an ESAL level of 10 to 30 million ESAL’s. The pavement was located in the immediate area of an on-ramp for an interstate highway. Pavement flushing, and in some areas, excessive rutting was observed for this area (Figure 5).

Figure 5 – Flushing and Rutting Located on Rt 921C, Utica, NY

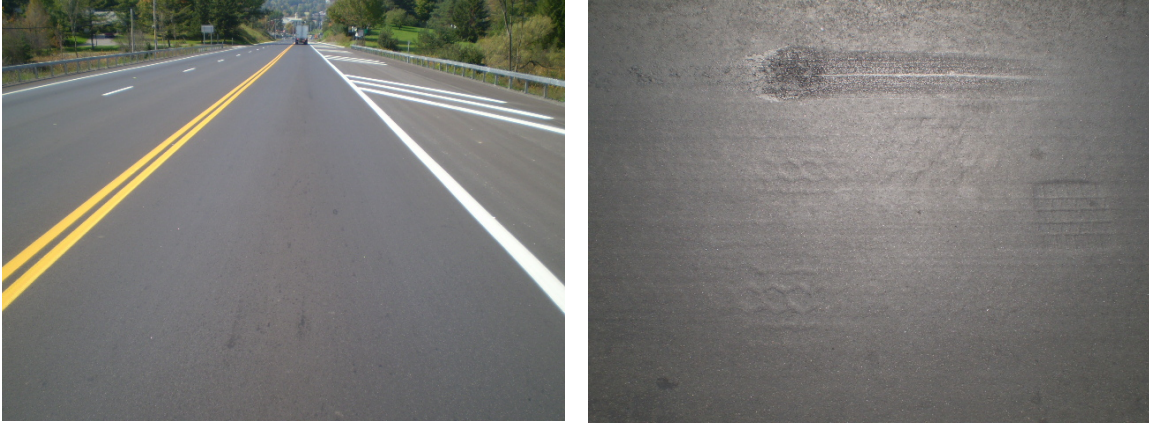
Rt 20 in Morrisville, NY was another pavement section that had traffic levels of 10 to 30 million ESAL's. The areas with extensive flushing were located at an incline/decline area (Figure 6).

Figure 6 – Flushing Located on Rt 20 in Morrisville, NY

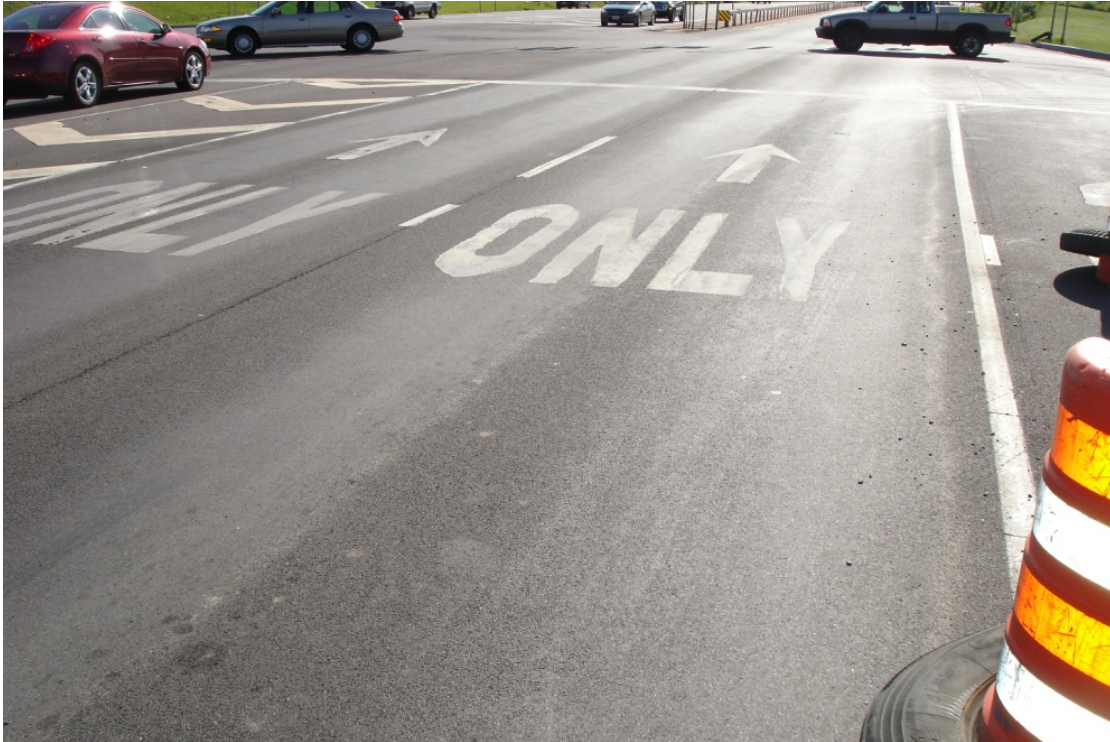
Another 10 to 30 million ESAL pavement section, the flushing and slight rutting on Rt 5 again occurred at an intersection (Figure 7). LTPPBind 3.1 was used to determine the correct PG grade used for the climatic and traffic conditions located in this area. Table 10 shows the results for this pavement section. Similar to the previous 10 to 30 million ESAL areas, the appropriate PG grade for this location should have been a high temperature grade of PG70. However, a PG64-28 asphalt binder was specified and utilized.

Figure 7 – Flushing at Intersection on Rt 5

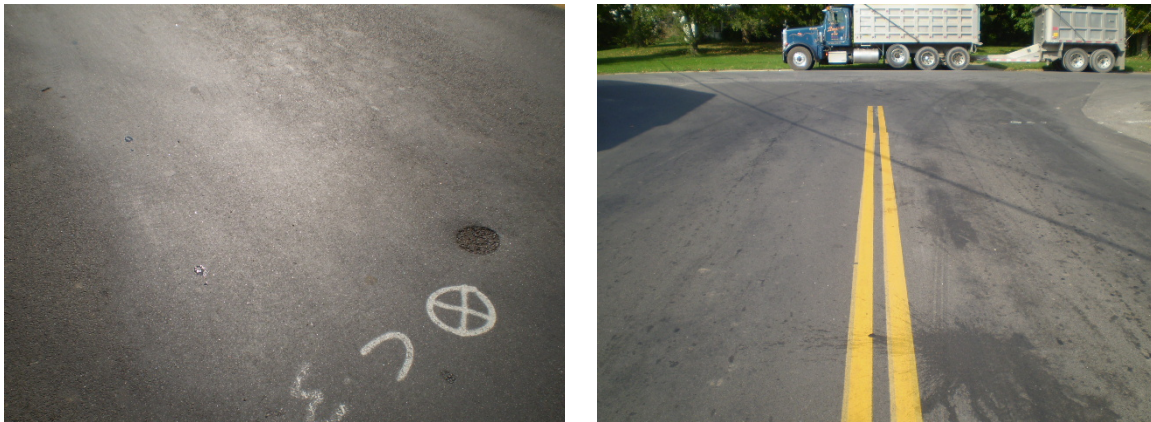
Rt 315 in Deansboro, NY (Region 2) is a low volume pavement section carrying < 3 million ESAL's. Again, flushing, although minor compared to the previously mentioned sections, was observed in an intersection area. And although the traffic was determined to be < 3 million ESAL's, construction vehicles do frequent the area, as shown in the photo below (Figure 8).

Figure 8 – Flushing at the Intersection of Rt 315 in Deansboro, NY (Region 2)

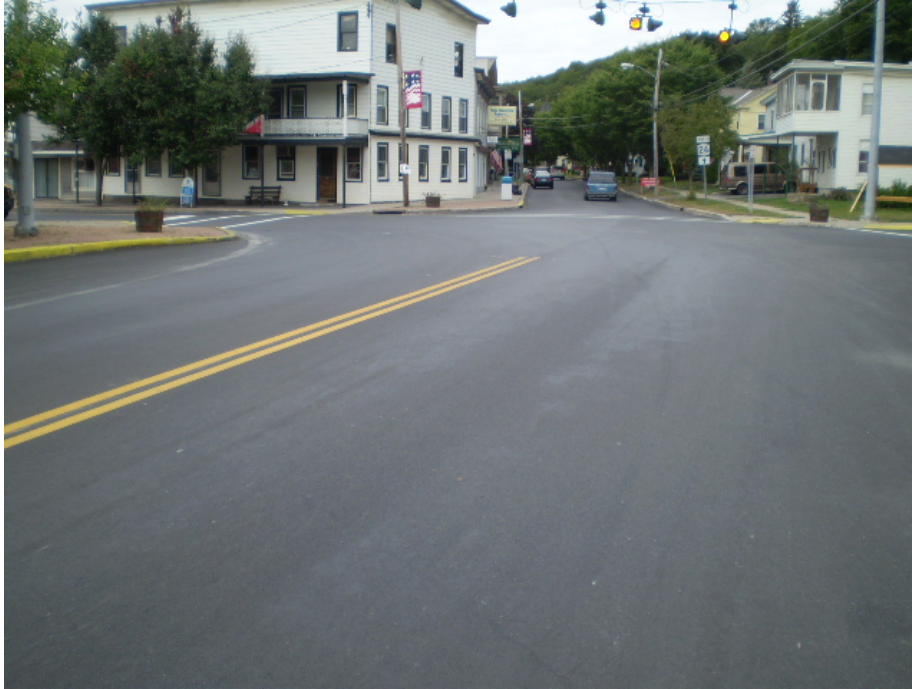
Rt 12B in Oriskany Falls, NY was identified as having minor flushing at the intersection area shown in the figure below (Figure 9). The pavement section in the immediate area was determined to be carrying < 3 million ESAL's.

Figure 9 – Flushing at the Rt 12B Intersection in Oriskany Falls, NY

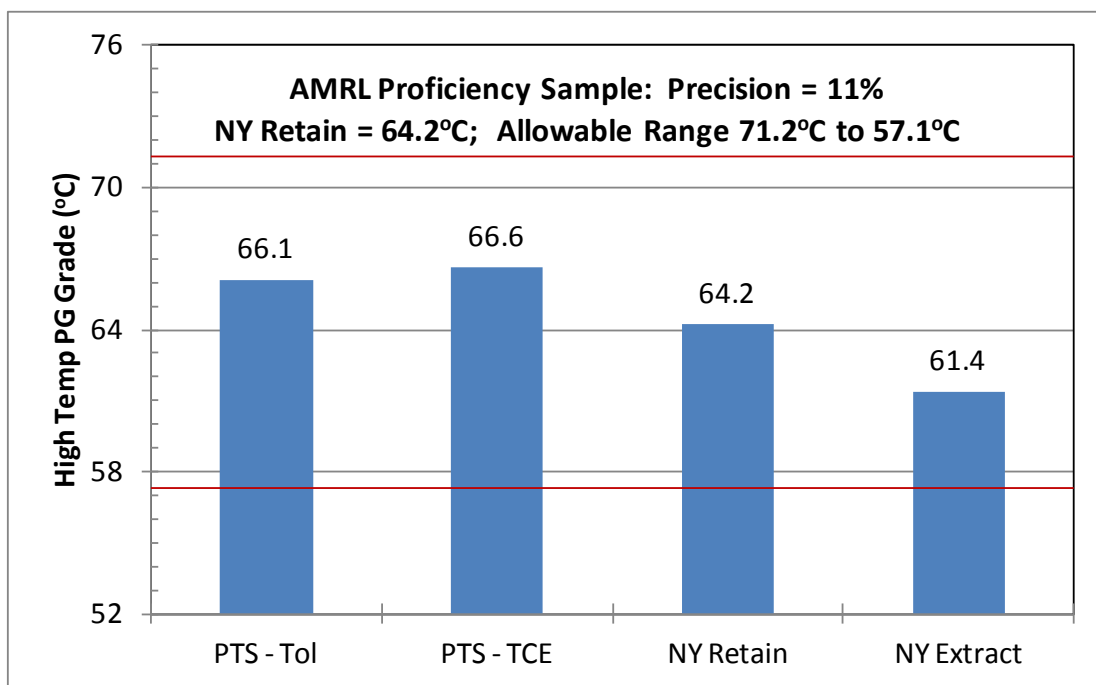
2. The figures clearly show that the resultant range of acceptable test results, based on the 11% coefficient of variation of the Retain values, surrounds the high temperature PG grade results for the extracted/recovered asphalt binders. All but 2 test results (two from Rt 365) from the NYSDOT and PTS extracted/recovered are found to be within the acceptable range. This would indicate that even though the NYSDOT resulted in extracted/recovered high temperature PG grades that fell below 64° C, the test results were within the expected range of repeatability.

Figure 10 – Comparison of High Temperature PG Grade for Rt 921C, Utica, NY (Genesee Street)

Figure 11 – Comparison of High Temperature PG Grade for Rt 20, Morrisville, NY

Figure 12 – Comparisons of High Temperature PG Grade for Rt 315, Deansboro, NY

Figure 13 – Comparison of High Temperature PG Grade for Rt 12B, Oriskany Falls, NY

Figure 14 – Comparison of High Temperature PG Grade for Rt 365, Rome to Barneveld, NY

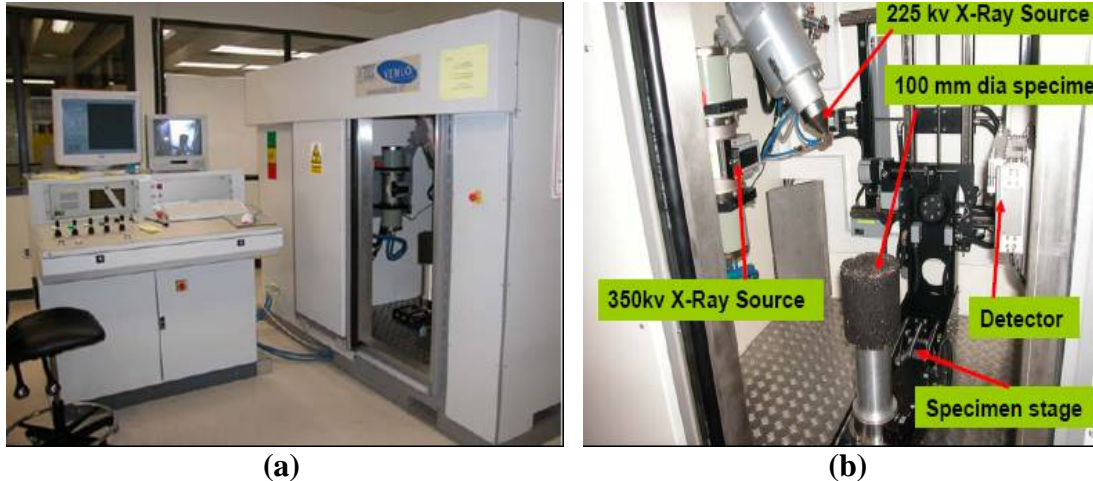
In an attempt to efficiently quantify the entire core, and not just a “slice”, X-ray Computed Tomography (CT) testing was conducted on selected cores from both flushed and unflushed sections of the pavement (in and outside the wheelpath). X-ray CT is a nondestructive test to capture the internal structure of materials. The X-ray CT setup at Texas A&M University is shown in Figures 16a and b. This setup includes two separate systems placed in the same shielding cabinet. The mini-focus system has a 350 kV X-ray source and a linear detector, while the micro-focus system has a 225 kV X-ray source and an area detector. The mini-focus source can penetrate thicker and denser specimens than the micro-focus source. The micro-focus system, however, has a better resolution than the mini-focus system. All the experimental measurements in this study shall be conducted using the mini-focus 350 kV X-ray source system. This system has the necessary power and resolution to penetrate the asphalt mix specimens and provide good quality images for air void/structural analysis.

Figure 16 - a) Overall X-ray CT System and Shielding Cabinet; b) Mini- and Micro-focus System

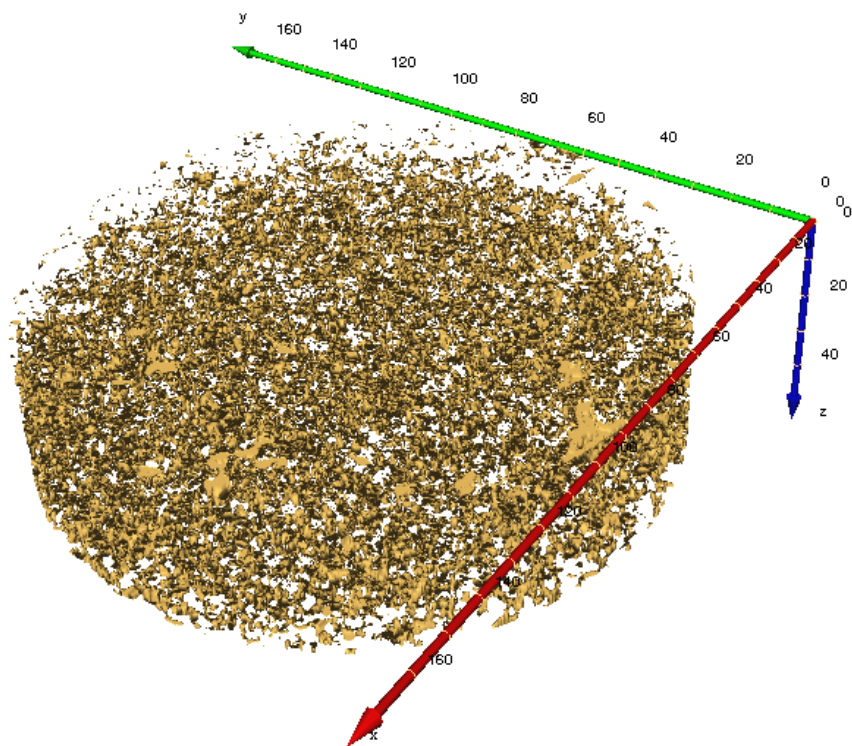
A 3-D representation of two field cores from Rt 96B, from inside and outside of the wheelpath, are shown in Figures 26 and 27. Both cores show a well distributed amount of aggregate within the core matrix. Although only one pavement location was evaluated, there is evidence suggesting that the visual observation made by Reinke (2009) may have been to just looking at a single saw cut and not represent the 3-D perspective of the field core.

Figure 26 – 3-D Representation of Rt 96B Field Core Taken from the Wheelpath

Figure 27 – 3-D Representation of Rt 96B Field Core Taken Outside of Wheelpath

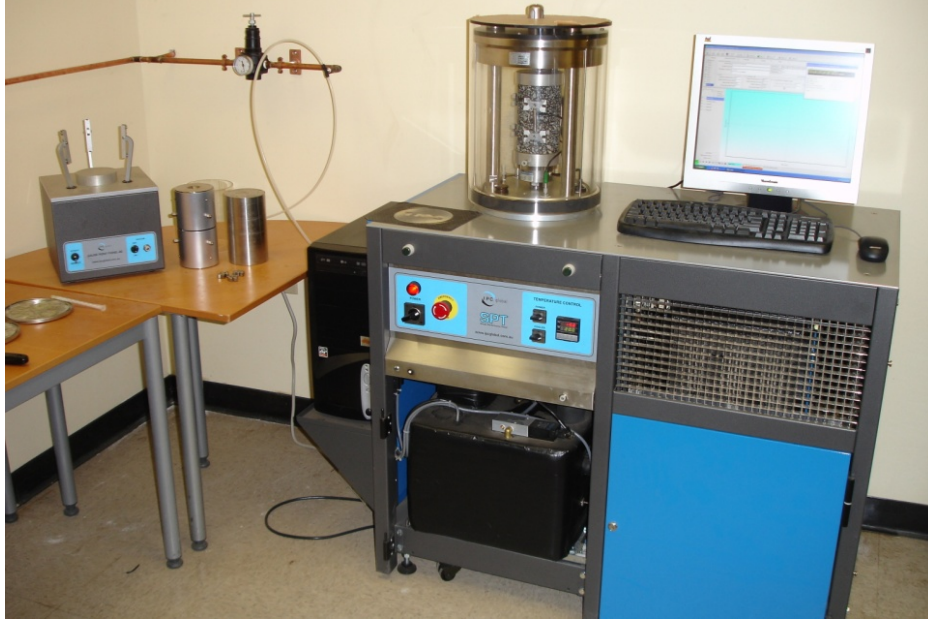
The collected modulus values of the varying temperatures and loading frequencies were used to develop Dynamic Modulus master stiffness curves and temperature shift factors using numerical optimization of Equations 1 and 2. The reference temperature used for the generation of the master curves and the shift factors was 20°C.

Figure 29 – Photo of the Asphalt Mixture Performance Tester (AMPT) at Rutgers University

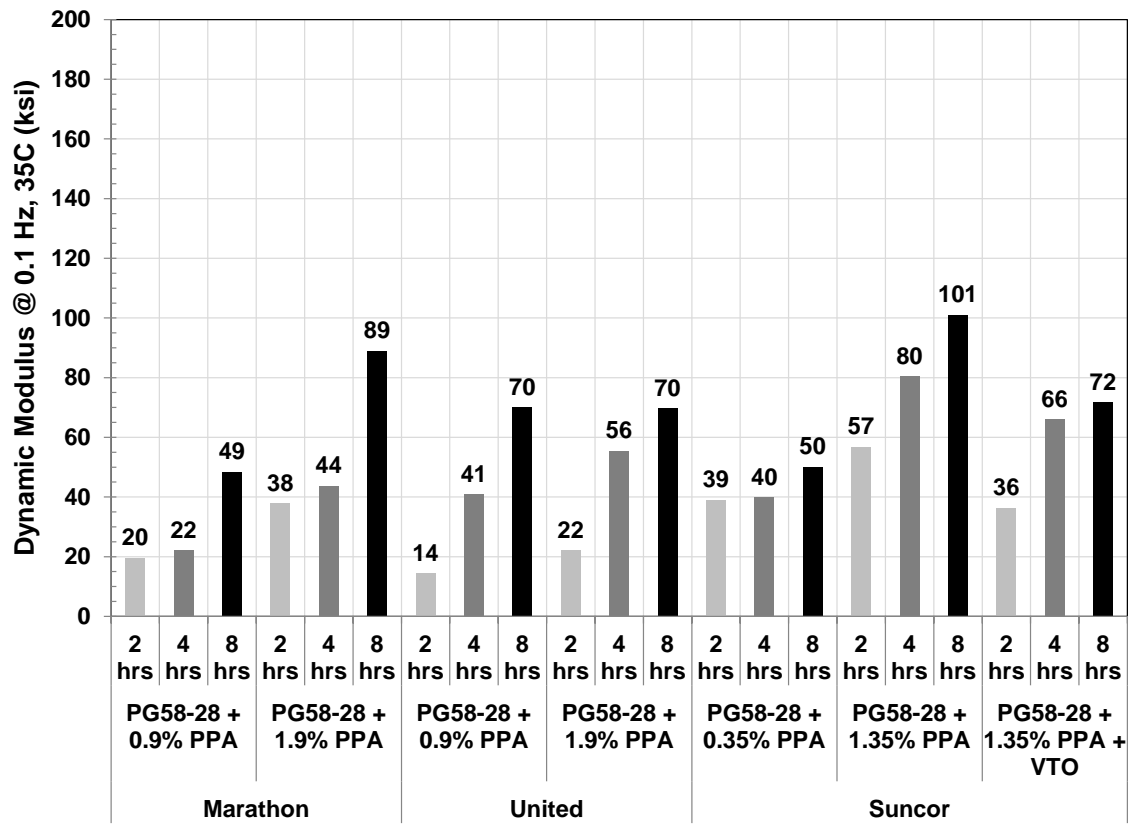
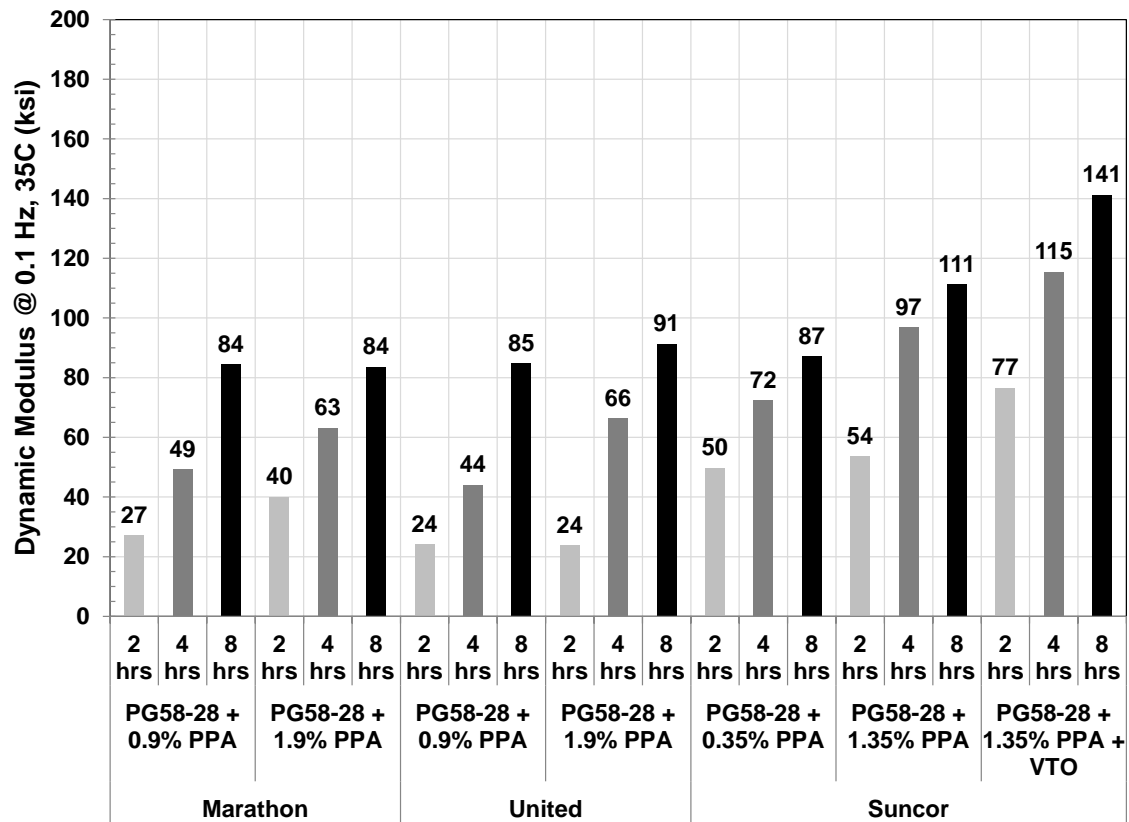
The Dynamic Modulus test results, at a test temperature of 35°C and loading frequency of 0.1 Hz, are shown in Figures 30 through 34. The test results indicate that as the conditioning time increased, the small strain stiffness measured in the Dynamic Modulus increased. There did not appear to be any softening due to aggregate-asphalt interaction due to the conditioning times used in this study.

Figure 30 – Dynamic Modulus Test Results at 0.1 Hz, 35°C for Hanson Aggregates – Region 2

Figure 31 – Dynamic Modulus Test Results at 0.1 Hz, 35°C for Rochester (Dolomite) – Region 4

Figure 32 – Dynamic Modulus Test Results at 0.1 Hz, 35°C for Suit Kote – Region 3

Figure 33 – Dynamic Modulus Test Results at 0.1 Hz, 35°C for Hanson Aggregates – Region 7

Figure 34 – Dynamic Modulus Test Results at 0.1 Hz, 35°C for Morlyn Asphalt – Region 9

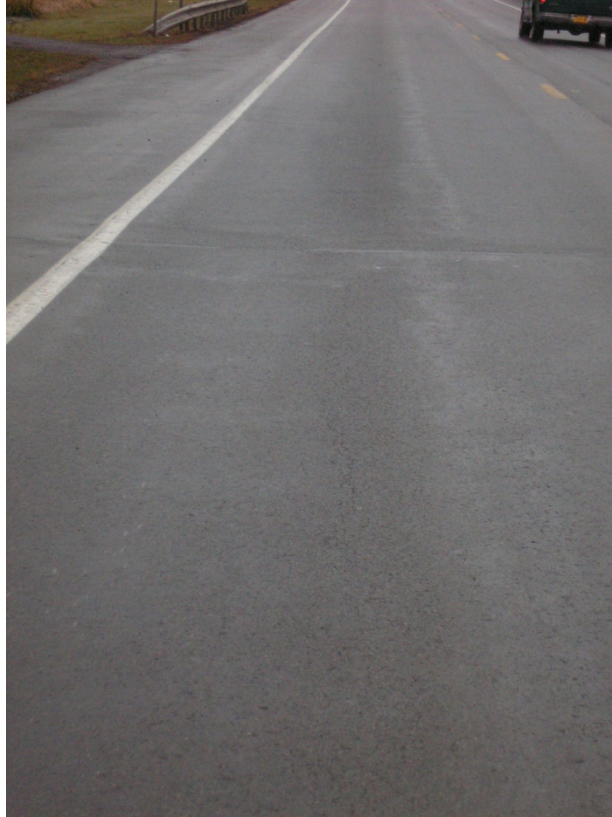
Figure 56 – “Wash-boarding” of 9.5 mm Surface Course in Region 3 (Rt 96B)

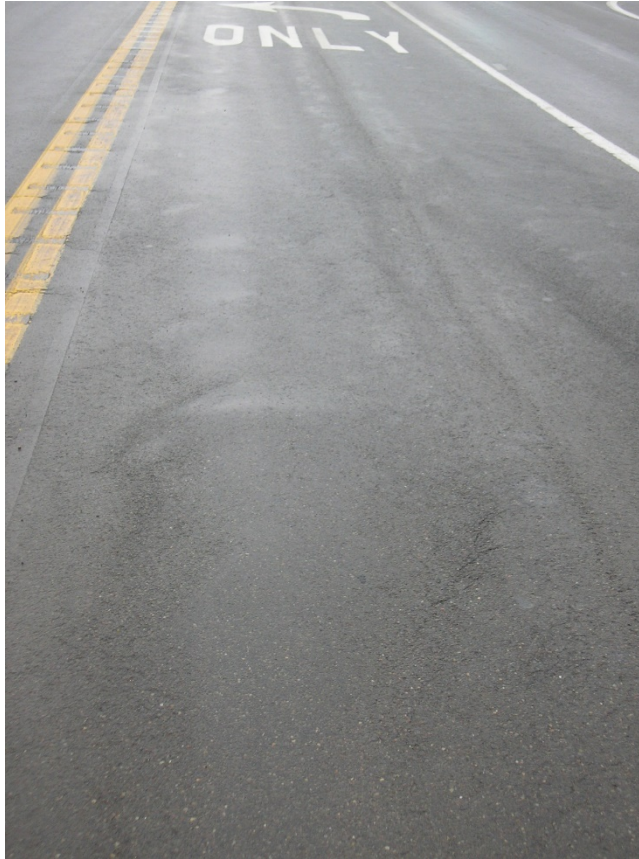
Figure 57 – Slippage Cracking in Dedicated Left Turn Lane in Region 3 (Rt 96B)
