Final Report

Subsurface Imaging of Corrosion in Painted Steel Bridges

Performing Organization: New York University

January 2014

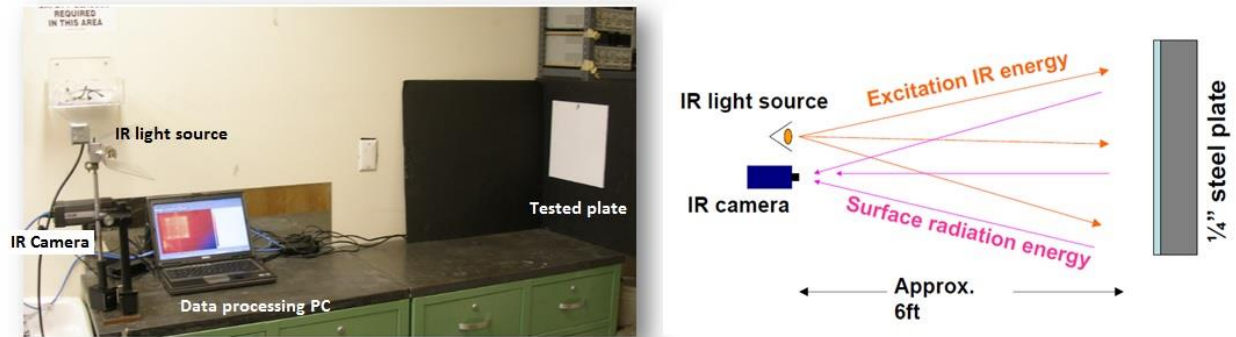
Figure 1. Lab experimental setup.

We used the FLIR A320 infrared camera and the Heraeus infrared lights installed as shown Figure 1 and imaged surface temperature of the plate with simulated defects.

Surface temperatures and its change were recorded at high frequency (apprx. 5 images per second) and recorded by our data processing PC.

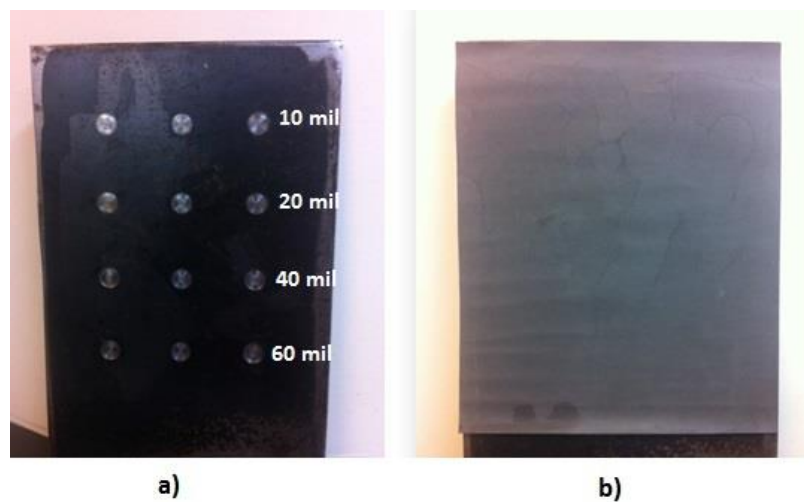
Figure 2. Steel plate with blind holes and simulated defects covered by protective coating.

The tested sample plate is structural steel plate $\frac{1}{4}$ " thick. The plate surface was brushed and sanded to remove corrosion and other deposits. We then simulated defects that can be presented under the coating. This procedure was conducted to calibrate defect detection.

Defects were simulated by creating blind holes in three rows with depths ranging from 10 to 60 mils, as shown in Figure 2 a). Each row has 60, 40, 20 and 10 mil deep flat bottom blind holes. Two rows were filled with corrosion compounds. The plate surface was covered with adhesive tape to simulate coating as shown in Figure 2 b).

For corrosion compounds we used are two common forms of iron oxides: Fe_3O_4 and Fe_2O_3 . Fe_3O_4 called magnetite is a black “sticky” powder that usually forms undercoating in the presence of acid environment. It usually later transforms to other form of iron oxide. Fe_2O_3 called hematite is a red-orange “fluffy” powder.

Adhesive tape was chosen as the coating option based on the following factors:

- thermal properties of adhesive tapes are similar to the hardened paints that are usually used for bridge applications;
- thicknesses of the adhesive tapes are relatively uniform and comparable to thicknesses of hardened paints;
- adhesive tapes do not fill the empty blind holes and voids in corrosion, and therefore do not interfere with thermal signatures of the defects.

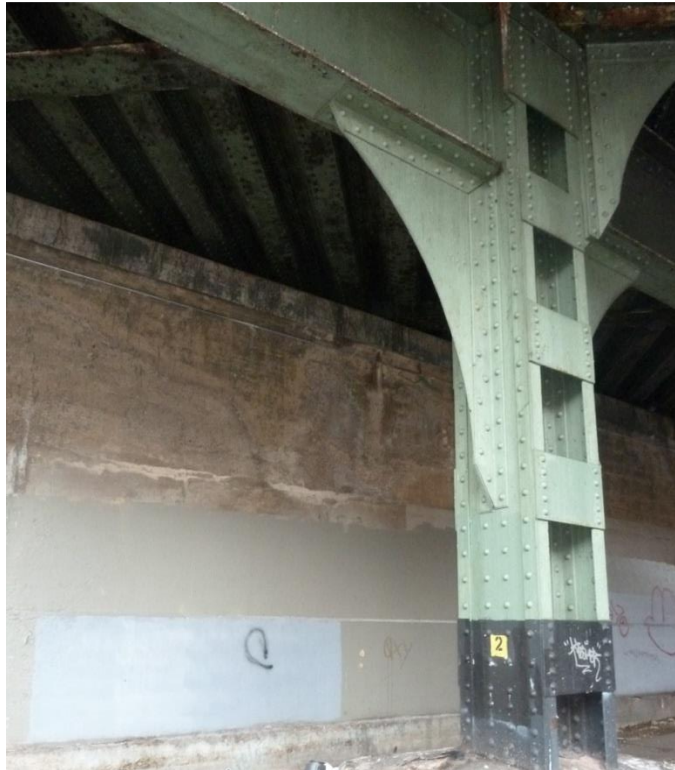
Figure 3. Overall bridge condition

Field testing was conducted on a particular steel bridge in the Bronx. This bridge serves as an overpass over Muliner Avenue for the MTA’s number 5 subway line. The bridge was chosen based on the visual inspection of protective paint as it appears to be representative of many locations. We were unable to verify when the bridge columns and beams were last repainted. Figure 3 depicts that protective coating

on the columns and girders is in relatively good condition. Figure 3 also shows the paint on the deck beams is significantly deteriorated.

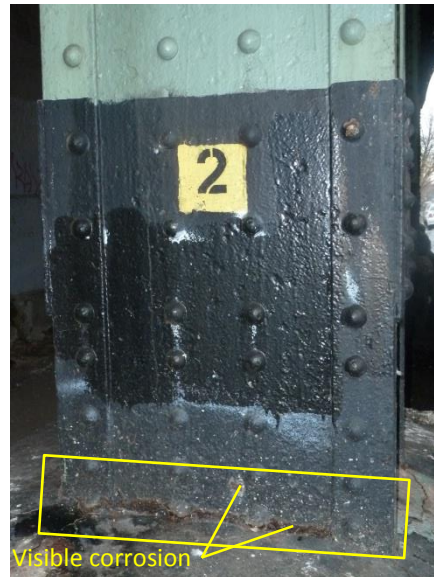
Figure 4. Bridge column typical conditions at base

The overall condition of the columns paint was good with few local areas of deterioration as shown in Figure 4. It appears to us that the paint on the column base has been repaired several times. Moreover,

there is no visible corrosion on the repaired paint surface, except areas close to the interface between column and concrete abutment.

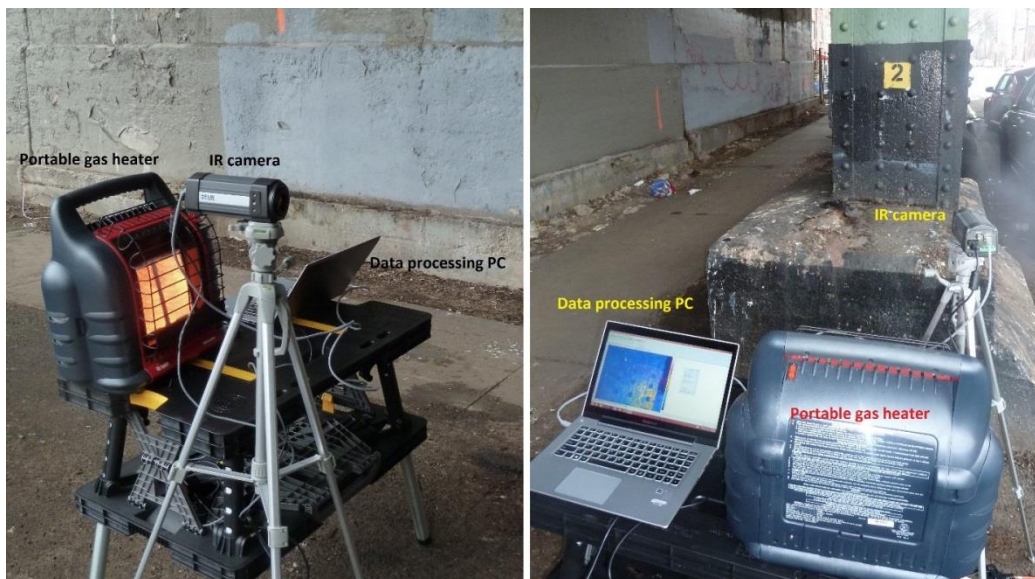
Figure 5. Equipment setup for active thermography inspection of bridge steel column

We inspected the column surface utilizing the active thermography technique. Column inspection setup is shown in Figure 5. Painted surface was stimulated by portable heater. The inspected surface of column was approximately 6 ft away from imaging camera and heater.

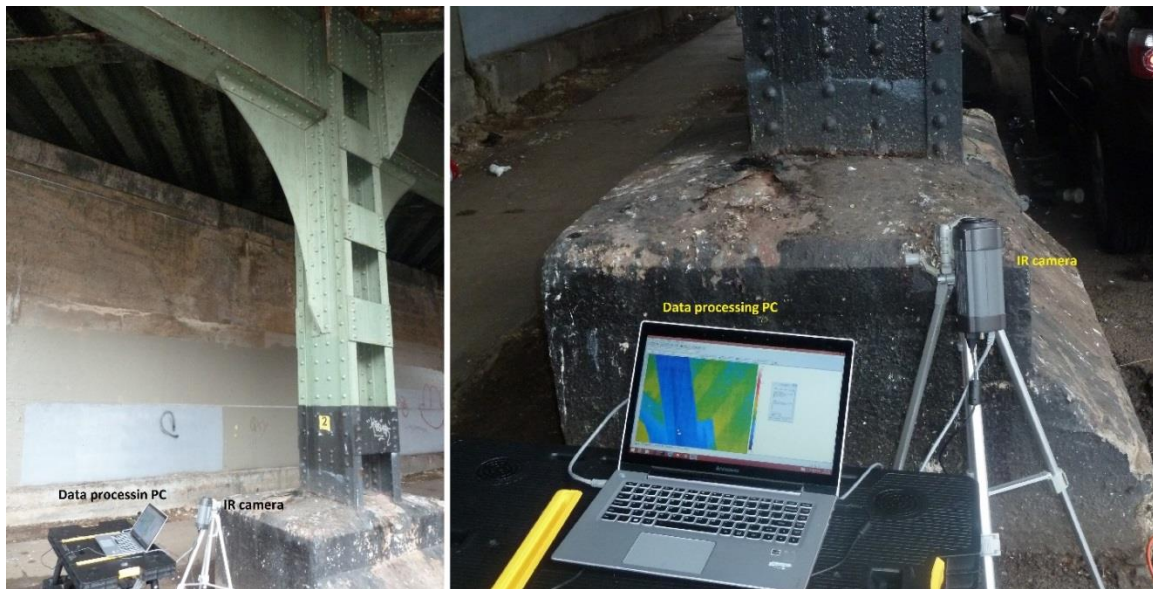
Figure 6. Equipment setup for thermography inspection of bridge steel beams

Bridge deck/beams were inspected from below. The inspected surface of the beams was located at distance of 25 ft. Beams inspection setup is shown in Figure 6.

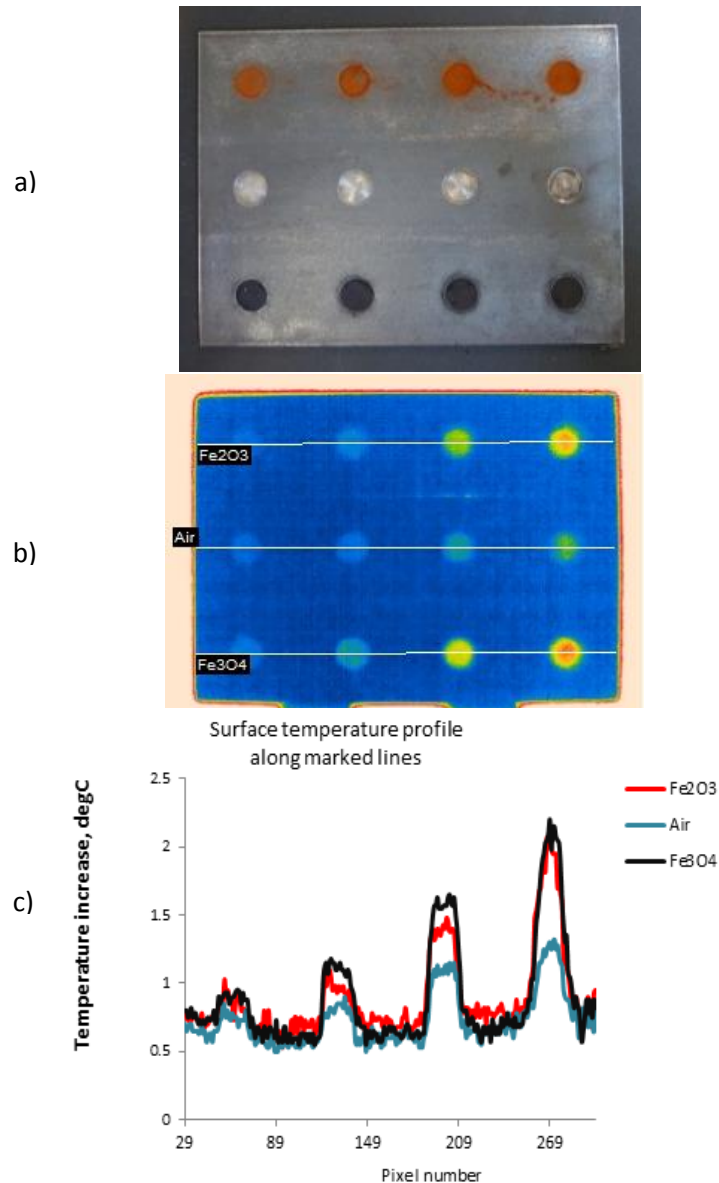
We stimulated the coated surface with controlled remote heat input using the IR heaters and recorded the observed temperatures at the surface. The presence of the defects was pronounced by higher temperatures over defect areas. Figure 7 a) presents locations of simulated defects before the coating was applied Figure 7 b) presents the surface temperature of the plate after 30 seconds heat stimulation. Figure 7 c) presents temperature rise along reference lines after the surface was heat stimulated.

Figure 7. Laboratory test results: a) Plate with simulated defects before coating is applied; b) Surface temperature after heat stimulation; c) Temperature rise profile along the reference lines after heat stimulation

From the data it is clearly seen that defects under coating are detectable by the higher temperature rises. We observed that raised temperature over a defect area is related to the depth of the corresponding blind hole, but there is little differentiation between corrosion types.

Air under the coating resulted in the smaller temperature rise over defect. This is somewhat contradictory to our expectation; but this may be explained by the sagging of the adhesive paper that reduces air gap. Moreover, corrosion compounds are not flush with the plate surface and are on average thickness is the larger than predicted.

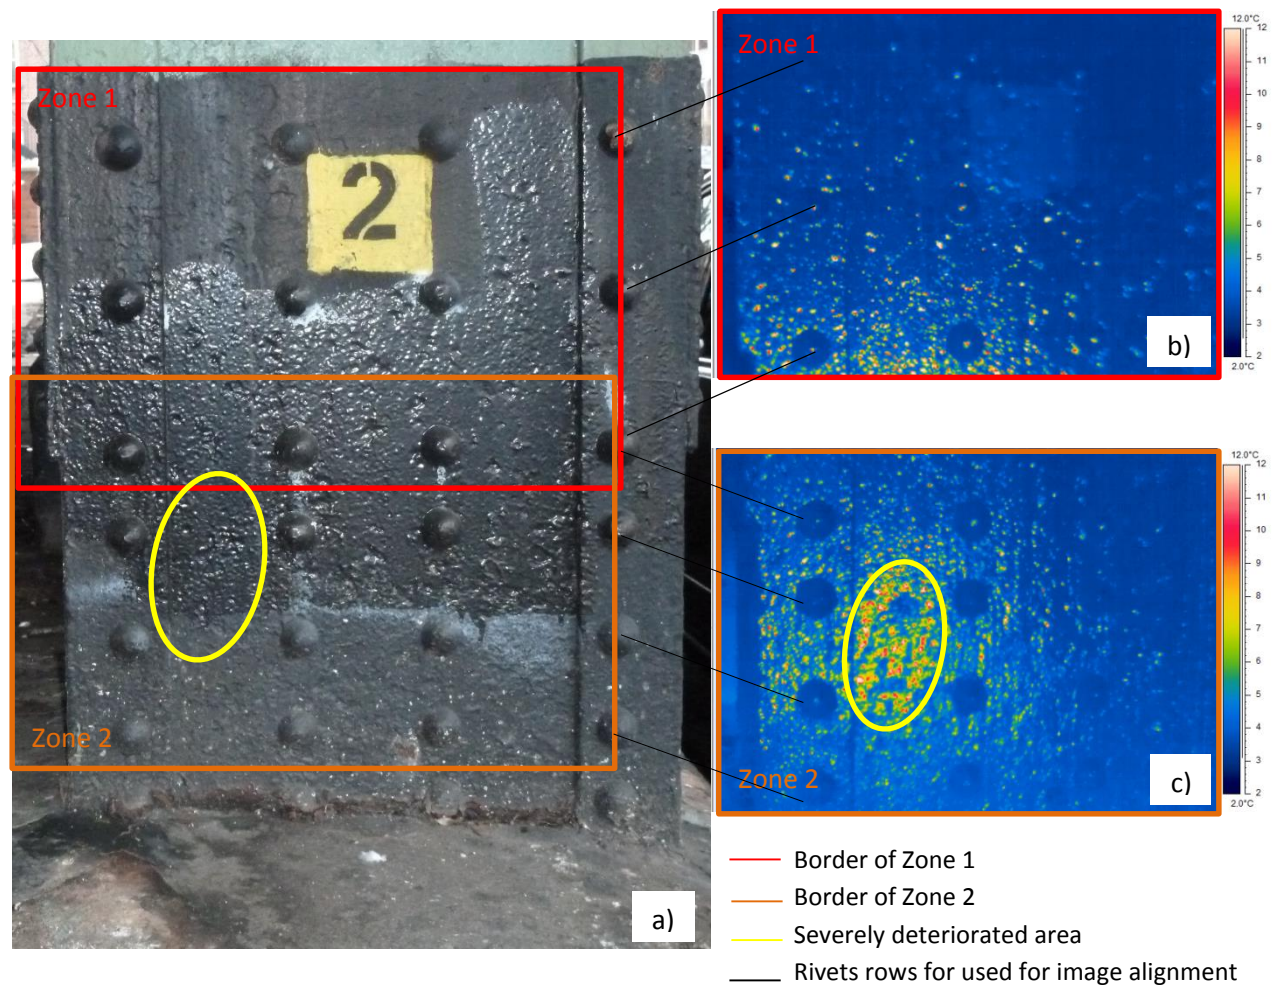
Results of column inspection are shown in Figure 8 below. Figure 8 a) shows visual image of inspected surface, inspection zones, area of significant subsurface defects that was identified during IR imaging.

Figure 8 b) shows results of IR inspection of the zone 1 after first heat stimulation. Figure 8 c) shows results of IR inspection of the zone 2 after a second heat stimulation.

Figure 8. Column inspection: a) Visual image of column base; b) IR image of zone 1 at column base; c) IR image of Zone 2 at column base.

Column inspection utilizing IR thermography reviled hidden defects under the paint. We imaged the surface temperature after repeating the heat stimulations. Repetitions were needed to cover the proposed inspection surface. Due to limitations of IR camera we divided inspected surface into zones. The IR images were matched to visual images by characteristic features (rivets in this case), which are distinctive in both image types.

Visual inspection did not suggest any defects under the freshly painted column base. We assume that coating repair was done recently based on presence of shiny black paint. However, the IR inspection revealed a deteriorated area was in zone 2. We believe that the possible cause of defects is due to inadequate surface preparation before fresh paint was applied.

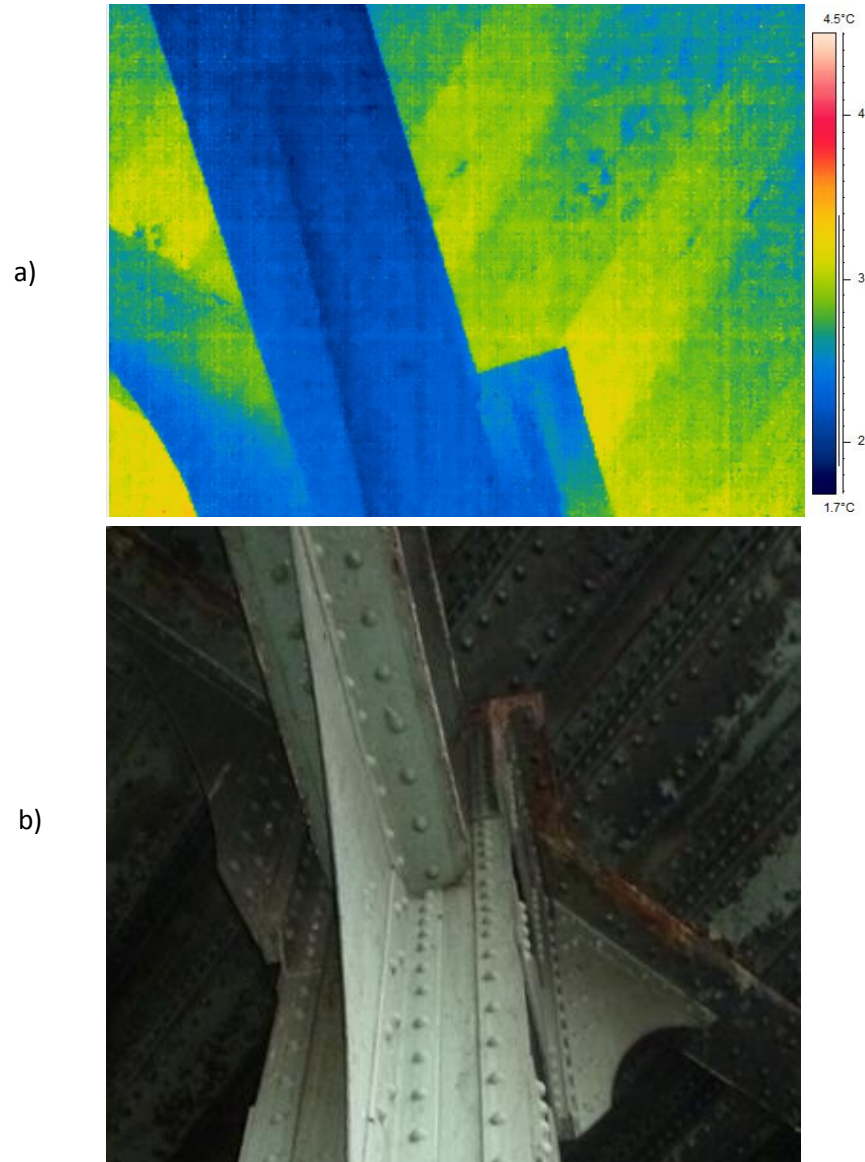
Beam inspection did not resulted in detectable defects, even though coating deterioration was visibly observable as shown in Figure 9 b). It is attributed to the relatively large distance to inspected surface, low IR camera resolution and inability to stimulate the surface by heat at such remote distance.

Figure 9. Deck beam IR inspection: a) Surface temperature after heat stimulation; b) Visible image of inspected area
