University Transportation Research Center - Region 2

# Experimental Study on Pre-stressed Concrete Box Beams From a Decommissioned Bridge Strengthened with Carbon Fiber Reinforced Polymer Anchors and Laminates

November 2023

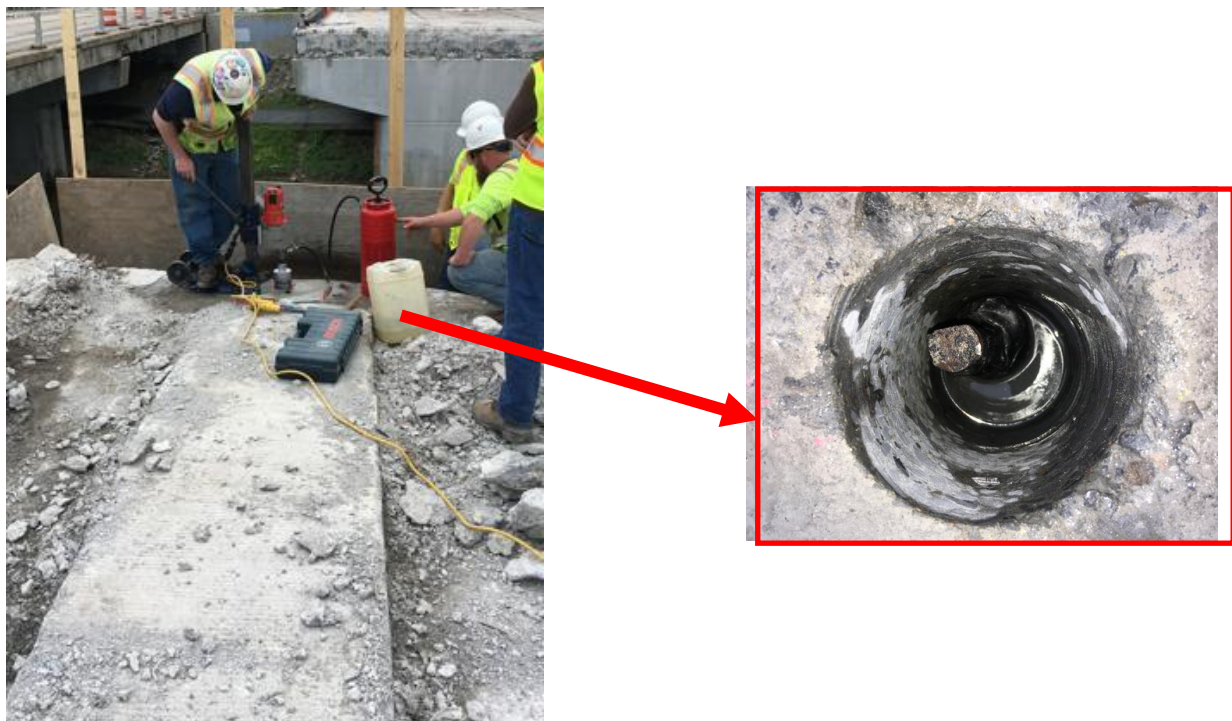
**Figure 2-5 Sample of core drilling around the anchors at the beam ends**

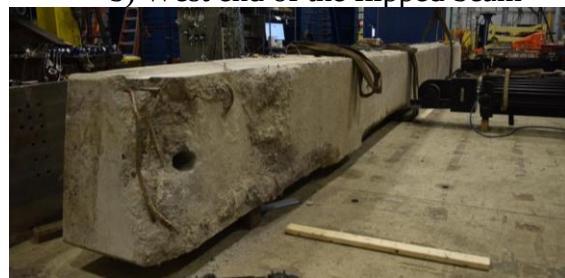
Beam 1 is shown in Figure 2-6. As discussed before, the concrete deck slab on both ends of the beam was removed prior to delivery. Except for minor concrete spalling and steel corrosion at

the west end, shown in Figure 2-6d, no other sign of damage or deterioration was observed. It should be noted that the cardinal coordinates, based on the beam orientation during testing at the SEES laboratory, are used in this report to refer to the various locations along their length. For instance, the “west end” refers to the end of the beam that is closer to the west side of the laboratory which remains the same for the entire testing period.

**Figure 2-6 Overall condition of Beam 1 upon delivery to the SEES laboratory**

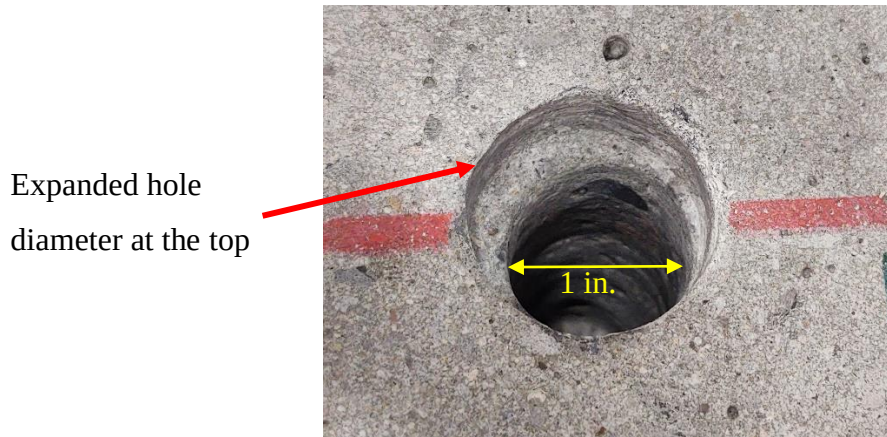
**Figure 3-5 Example of the drilled holes**

After the surface was prepared, 1-in.-diameter 4.5-in.-deep holes were drilled according to the design layout for each beam. The holes were  $\frac{1}{4}$  in. wider and  $\frac{1}{2}$  in. deeper than the anchor diameter and embedment depth, respectively. This is standard application practice as it allows for the epoxy to surround the anchor and provide a strong bond between the anchor and concrete. The top  $\frac{1}{2}$  in. of each hole was also widened by  $\frac{1}{4}$  of an inch in diameter towards the side of the anchor spread on the beam surface, as shown in Figure 3-5. This was done to prevent the anchor from bending 90 degrees and reduce the bearing stress concentration between concrete and the anchor at the bent segment of the anchors.

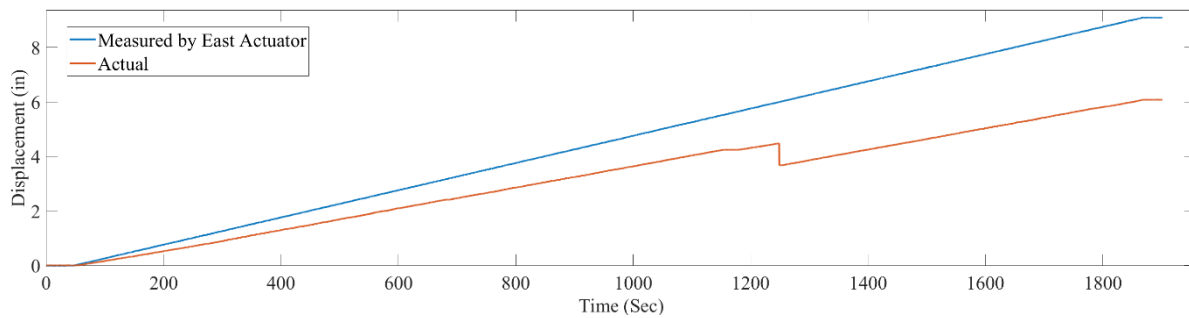
This is presented in Figure 5-11, which shows that the actuator displacement reading, which was used by a controller to give displacement commands to the actuator, was exceeding the actual displacement due to a calibration error. Therefore, the east actuator was only displacing about 80% of the given command and consequently, it was applying lower force compared to the west actuator. This problem was fixed for the following tests.

**Figure 5-11 Error in the displacement read by the East actuator**

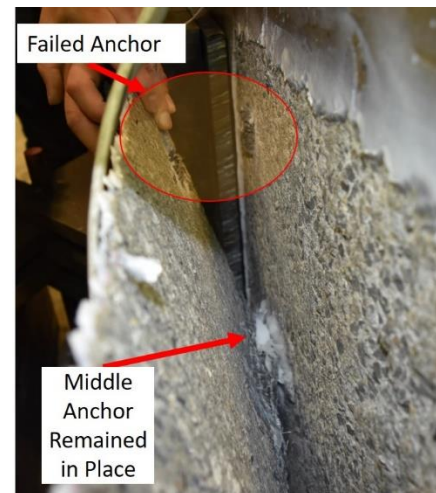
b) view to FRP-concrete interface

Figures 5-15 through 5-17 present the state of the damage following the FRP failure. Spalling of concrete cover attached to the FRP was observed, exposing the prestressing strands. Also, the anchors on the west side of the beam were pulled out along with a cone of concrete surrounding them as shown in Figure 5-16. The FRP laminate slid relative to the concrete at the west end of

the beam, rupturing one anchor and leaving the other two in place as shown in Figure 5-17. The retrofit on the east side of the beam did not exhibit noticeable damage. It should be noted again that this difference in the state of damage between the east and west sides was most likely the result of the difference in the applied forces between the actuators that resulted in unsymmetric loading. Since the FRP system could not provide any resistance beyond its failure, the loading of the beam was continued, as this would allow to obtain the behavior of the unretrofitted beam. The loading stopped once the beam failed due to concrete crushing on the compression side.

**Figure 5-17 FRP sliding at the West end of Beam 1**

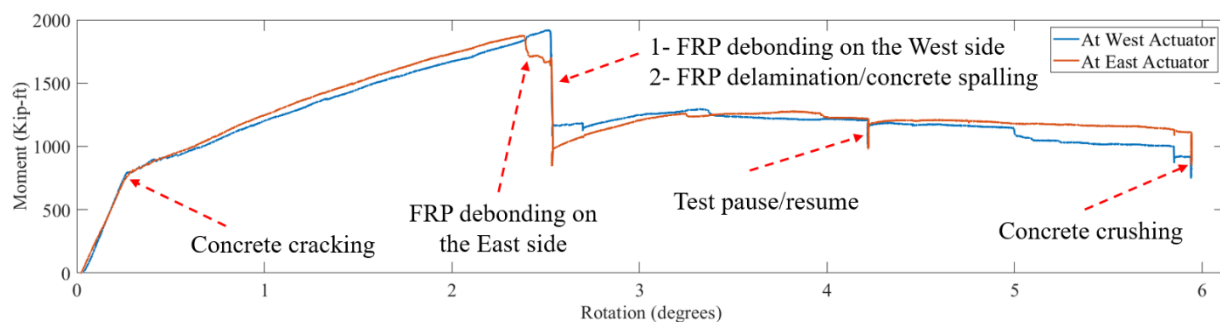
Following the beam cracking, the applied load was resisted until debonding of FRP laminate was initiated on the East side of the beam as indicated in Figure 5-26. The debonding can also be inferred from the drop in the strain on the East of the beam as illustrated in Figure 5-28 and Figure 5-29. It can be also observed from Figure 5-29 that the strain in the laminate increased at the east end, indicating a redistribution of the force. Following this event, the total force resisted by the beam remained constant until debonding of FRP laminate occurred on the west side, which was shortly followed by FRP delamination and concrete spalling as the bond between the FRP and the concrete was strong enough to cause spalling of the concrete cover. This sequence of events can be observed in the plots of Figure 5-29 that focus on the failure region of response.

**Figure 5-26 Moment vs. beam rotation during the capacity test of retrofitted Beam 2**

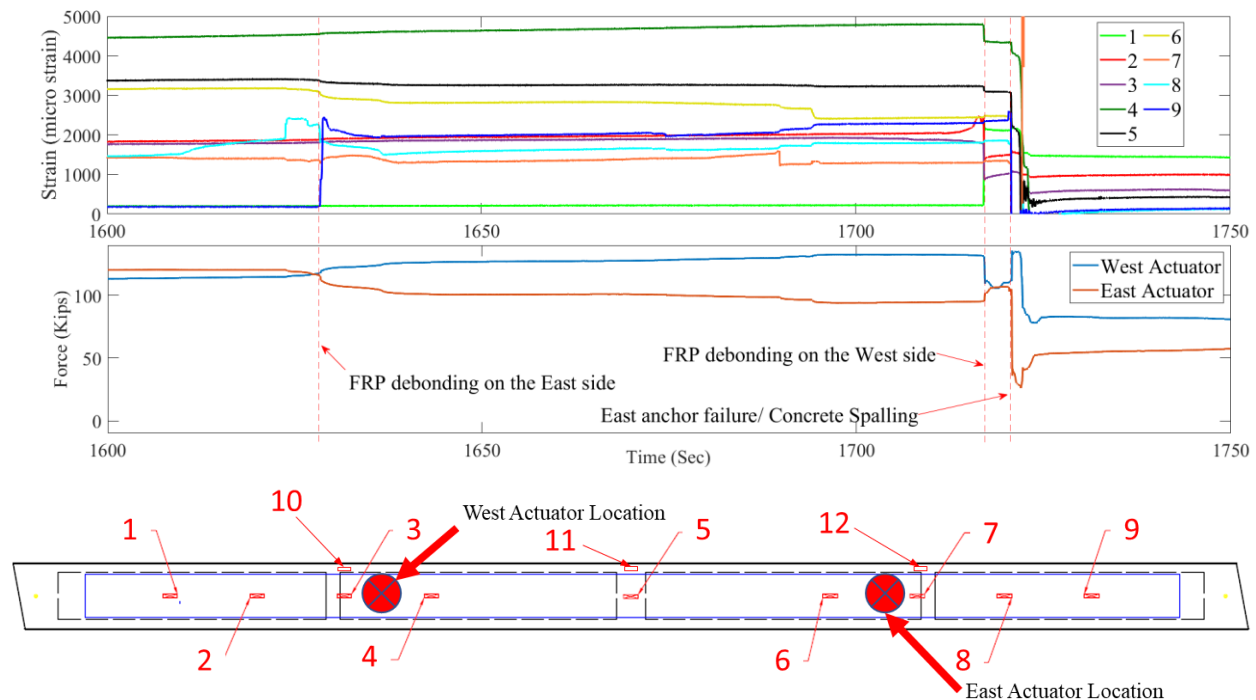
**Figure 5-29 Variation of strain during the failure of the FRP retrofit**
