August 8, 2007 Storm Report

I. Executive Summary

Climate Component

MTA 8.8.07 Task Force Report

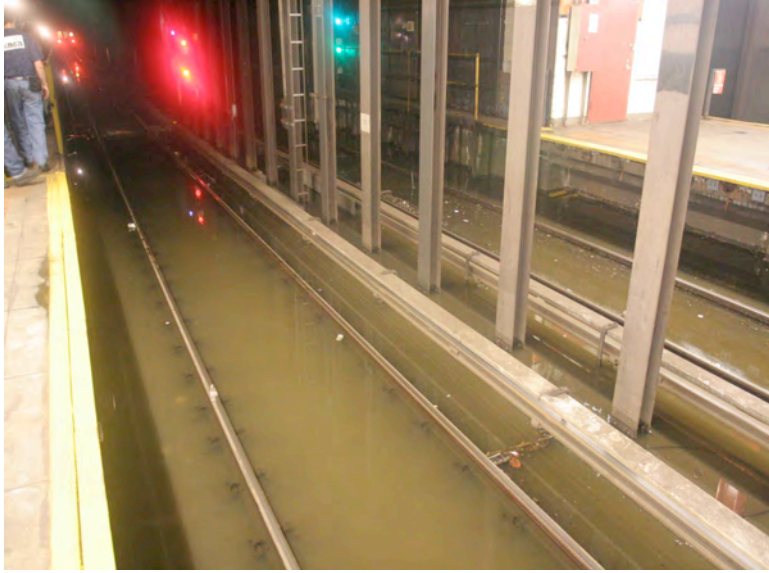
Figure 3
*F Line Hillside Ave Related
Flooding*

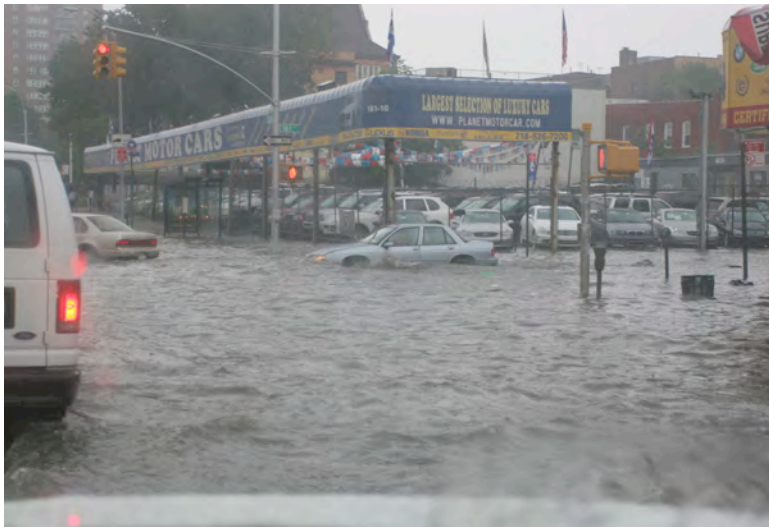
Figure 4
*F Line Hillside Ave
Flooding*

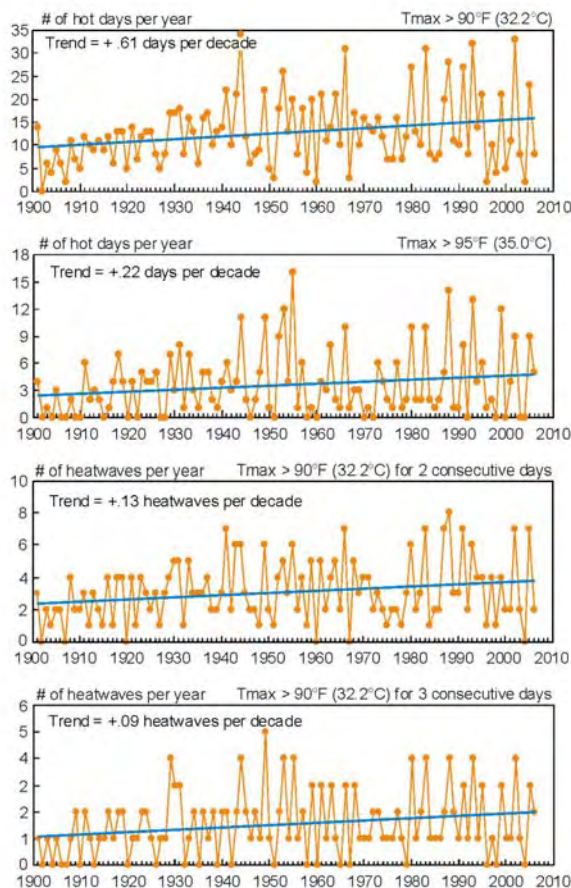
Hot days and heat waves may be defined in several ways using daily data, which are available for Central Park since 1900 (Figure 3):

- 1) Individual days with maximum temperatures above 90°F (32.2°C),
- 2) Individual days with maximum temperatures above 95°F (35°C),
- 3) Two consecutive days with maximum temperatures above 90°F (32.2°C) and
- 4) Three consecutive days with maximum temperatures above 90°F (32.2°C).

Figure 3: Hot days and heat waves in Central Park, based on maximum temperatures exceeding: 90°F, 95°F, 90°F for two consecutive days, and 90°F for three consecutive days.

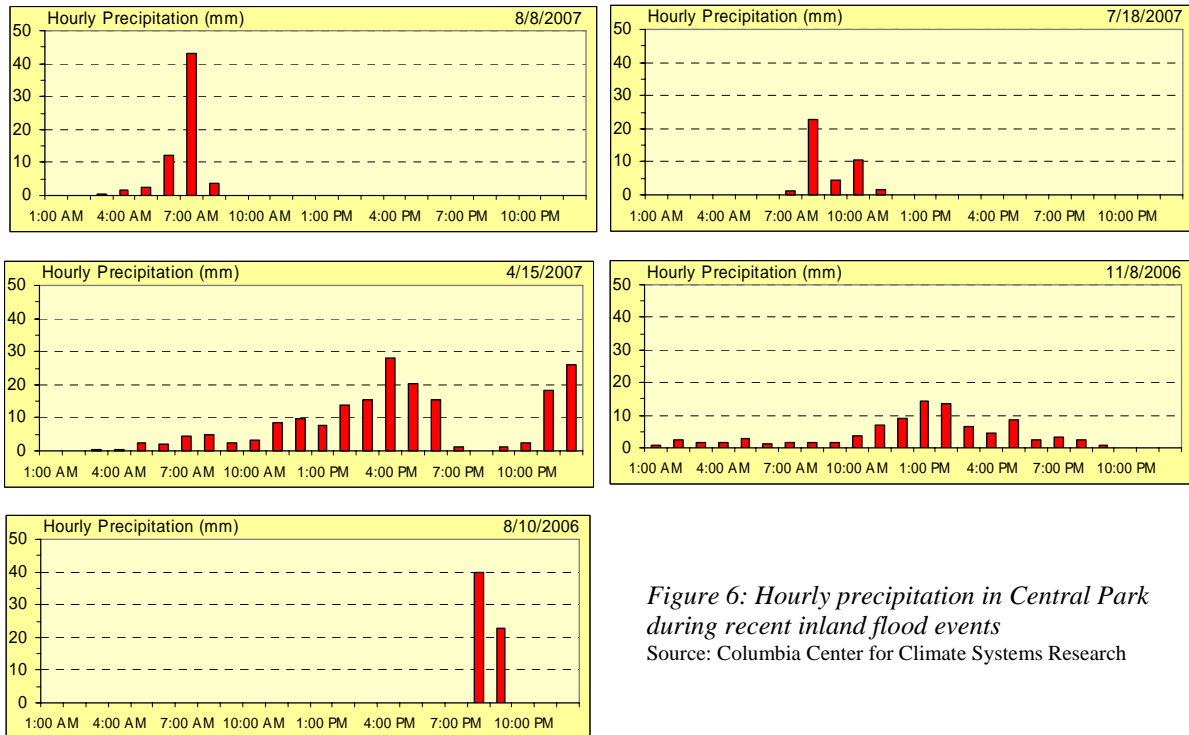
Figure 6: Hourly precipitation in Central Park during recent inland flood events
 Source: Columbia Center for Climate Systems Research

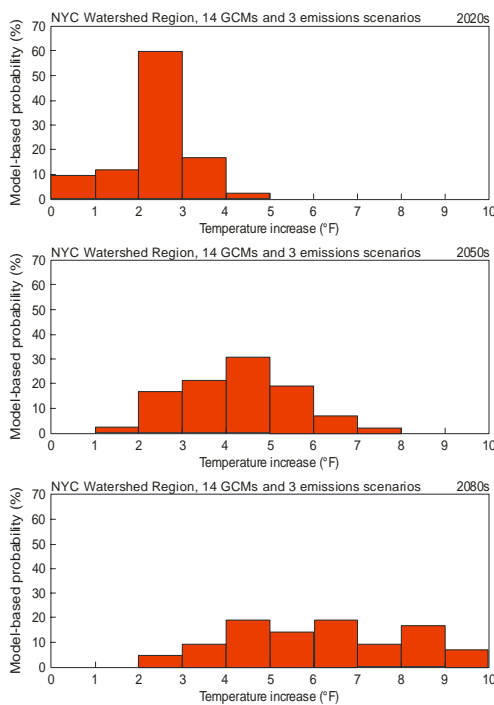
Figure 10: Estimated temperature changes (°F) in NYC watershed, relative to the 1970-1999 base period, for 14 models and three emissions scenarios. Frequency distribution shown.
Source: Columbia Center for Climate Systems Research

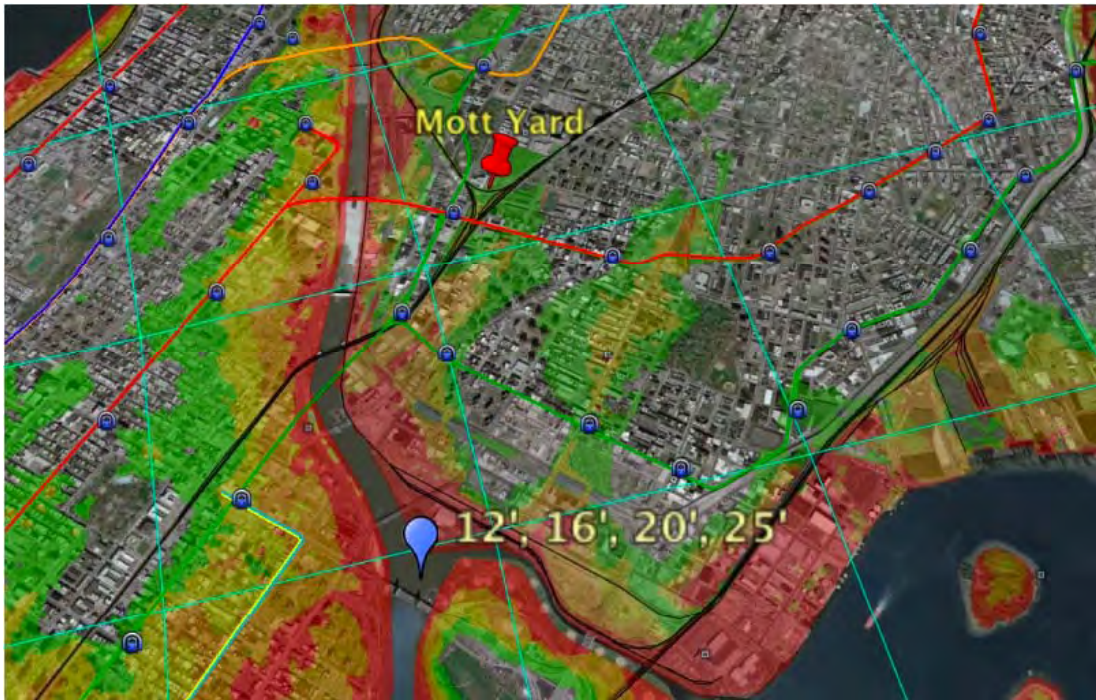
Figure 14: Location of the Mott Yard, Bronx, at the Y-shaped branching of the Metro North Lines. The Hudson Line takes the NW branch, and the Harlem/New Haven Lines take the NE branch of the 'Y' pattern of tracks (in gray). Note their combined SW crossing of the Harlem River into Manhattan to continue into Grand Central Station. Also shown is the relation to storm surge flood zones for worst-case tracks of hurricanes with different Saffir-Simpson (SS) categories. SS1 flood zone in red, SS2 in brown, SS3 in yellow, and SS4 in green. The blue grid defines the cells for the SLOSH computations for which the storm surge heights were calculated by the US Army Corps of Engineers / National Weather Service. At the location of the blue symbol, the approximate SLOSH worst-track storm surge heights are indicated; for SS1 about 12 feet; SS2 about 16 ft; for SS3 about 20 ft; for SS4 about 25 ft. Note that the likelihood of an intense worst-track hurricane is very low. See text for details.

Such surges could enter from the tidal Harlem River. However, the tracks become increasingly elevated, relative to the southwest sloping ground, as the tracks cross the Major Deegan Expressway (I-87) and the Harlem River. Track elevations at the Mott Yard measure between about 14 and 19 feet (4.3 and 5.8 m) above current mean sea level. The center of the Y and its valley floor have benefited from an improved drainage along the Harlem line, but drainage of the Mott Yard is seemingly still insufficient. The problem may in part stem from a system of east-to-west running and sloping streets that bring runoff towards Park Avenue. The catch basins along Park Avenue and the storm

sewers and siphons should be checked for their capacity to drain the excess runoff from these easterly striking cross streets (E 149th to E 154th Street, and perhaps beyond).
